# Access Compliance Report

## Public Rights-of-Way

### (Curb Ramps)

Intersection ID: 28484	Main Street: ELM_LN	Cross Street: WINDSOR_RIDGE_DR	Location: SE
ADA ID: A04E615DF447	Ramp Type: PerpDiag	Initial Pass/Fail: Fail	Overall Compliance: No
		Severity Score: 50

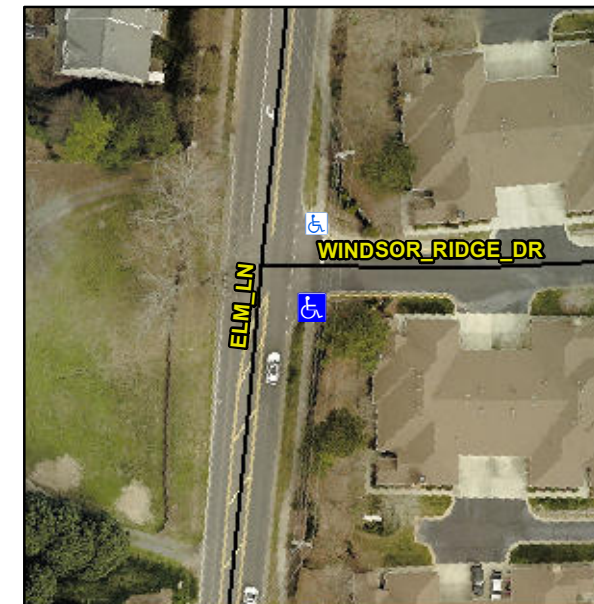
**Not Found, R304.2.2, R304.5.3**

Compliance	Description	Data	Compliance	Description	Data
N/A	Ramp Length (in)	36.0	No	Ramp Slope (%)	16.2
Yes	Ramp Width (in)	48.0	No	Ramp XSlope (%)	11.5
N/A	Flare Type LT	N/A	N/A	Flare Type RT	N/A
N/A	Flare Slope LT (%)	N/A	N/A	Flare Slope RT (%)	N/A
N/A	Flare Traversable LT?	N/A	N/A	Flare Traversable RT?	N/A
N/A	Landing Length (in)	N/A	N/A	DWS Provided?	N/A
N/A	Landing Width (in)	N/A	N/A	DWS Contrast?	N/A
N/A	Landing Slope (%)	N/A	N/A	DWS Length (in)	N/A
N/A	Landing X Slope (%)	N/A	N/A	DWS Full Width?	N/A
N/A	Landing Curb? (Y/N)	N/A	N/A	DWS Offset (in)	N/A
N/A	Shared Landing?	N/A			
N/A	Gutter Ponding?	N/A	N/A	Gutter Slope (%)	N/A
N/A	Gutter Lip Ht (in)	N/A	N/A	Gutter X Slope (%)	N/A
N/A	Painted X Walk1?	No	N/A	Painted X Walk2?	No
	X Walk 1 Direction	To NE		X Walk 2 Direction	To NW
N/A	X Walk 1 Width (in)	N/A	N/A	X Walk 2 Width (in)	N/A
	X Walk 1 Slope (%)	2.1		X Walk 2 Slope (%)	6.2
	X Walk 1 X Slope (%)	7.4		X Walk 2 X Slope (%)	2.3

N/A	Ramp inside XWalk1?	N/A	N/A	Ramp inside XWalk2?	N/A
	Road Slope (%)	6.3	N/A	Clear Space?	N/A
	Road X Slope (%)	3.0	N/A	Clear Space to XWalk (in)	N/A
N/A	Any Obstructions?	N/A	N/A	Storm Grate/Utility Hazard?	N/A
	Obstruction Type			Storm Grate/Utility Type	
		N/A			N/A
			Yes	Surface Condition? (G/P)	Good

**Remove & Replace Curb Ramp With Two New Directional Ramps or Equivalent.**
