Access Compliance Report

Public Rights-of-Way

(Curb Ramps)

Intersection ID: 16755	Main Street: DICKINSON_PL	Cross Street: PRINCETON_AV	Location: SE
ADA ID: A04E6F71ED09	Ramp Type: Directional1	Initial Pass/Fail: Fail	Overall Compliance: No
Codes/Mitigation Info/Possible Solution		Field Measurements/Component Compliance	
Severity Score: 13.75

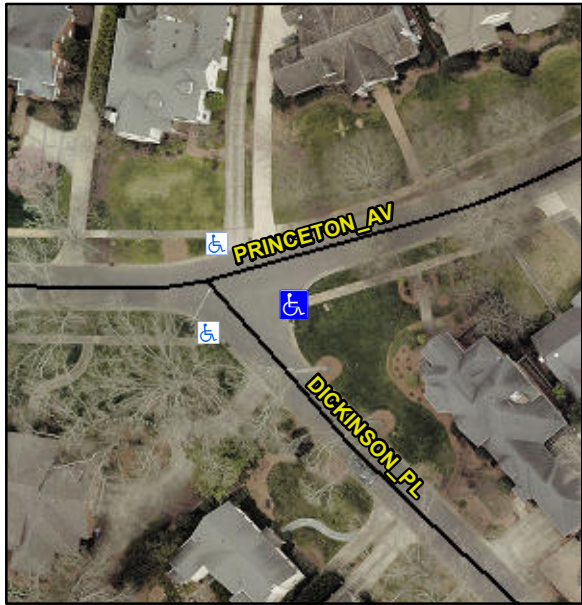
Compliance	Description	Data	Compliance	Description	Data
N/A	Ramp Length (in)	24.5	N/A	Grade Break?	N/A
Yes	Ramp Width (in)	58.0	N/A	Grade Break Slope (%)	0.0
No	Ramp Slope (%)	8.6	N/A	Grade Break XSlope (%)	0.0
No	Ramp XSlope (%)	2.1			
N/A	Flare Type LT	N/A	N/A	Flare Type RT	N/A
N/A	Flare Slope LT (%)	N/A	N/A	Flare Slope RT (%)	0.0
N/A	Flare Traversable LT?	N/A	N/A	Flare Traversable RT?	N/A
N/A	Landing Length (in)	0.0	N/A	DWS Provided?	N/A
N/A	Landing Width (in)	0.0	N/A	DWS Contrast?	N/A
N/A	Landing Slope (%)	0.0	N/A	DWS Length (in)	N/A
N/A	Landing X Slope (%)	0.0	N/A	DWS Full Width?	N/A
N/A	Landing Curb? (Y/N)	N/A	N/A	DWS Offset LT (in)	N/A
N/A	Shared Landing?	N/A	N/A	DWS Offset RT (in)	N/A
N/A	Gutter Ponding?	0.0	N/A	Gutter Slope (%)	N/A
N/A	Gutter Lip Ht (in)	0.0	N/A	Gutter X Slope (%)	N/A
N/A	Painted X Walk1?	No		Road Slope (%)	4.5
	X Walk 1 Direction	To SW		Road X Slope (%)	2.9
	X Walk 1 Width (in)	N/A		Clear Space?	N/A

X Walk 1 Slope (%)	4.5	N/A	Clear Space to XWalk (in)	N/A
	X Walk 1 X Slope (%)	2.9	N/A	Storm Grate/Utility Hazard?	N/A
N/A	Ramp inside XWalk1?	N/A		Storm Grate/Utility Type	
N/A	Any Obstructions?	N/A			N/A
	Obstruction Type		Yes	Surface Condition? (G/P)	Good
		N/A	N/A	Curb Slope (%)	22.4

Possible Solutions:				
	Remove & Replace Entire Ramp.				
	Surveyor Notes:				
	N/A				
	PROW/ADA:				
	R304.2.2, R304.5.3				
	Street 1 Name		DICKINSON PL		
	Stop Condition-Street 1		StopSign		
	Street 2 Name		N/A		
	Stop Condition-Street 2		N/A		
Total Cost:		\$	1600.00
