Access Compliance Report Public Rights-of-Way (Curb Ramps)

Intersection ID: 11872 Main Street: E_19TH_ST Cross Street: PEGRAM_ST Location: NW ADA ID: A04EB1D04284 Ramp Type: PerpDiag Initial Pass/Fail: Fail **Overall Compliance: No** Severity Score: 61.25

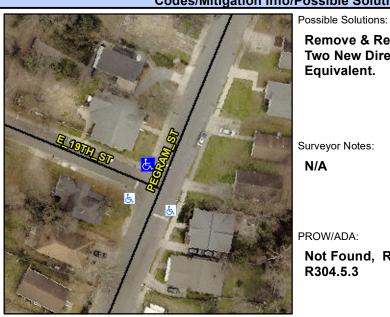
Comp	liance Description	Data	Comp	liance	Description	Data
N/A	Ramp Length (in)	58.0	No	Ramp	Slope (%)	12.2
No	Ramp Width (in)	20.0	No	Ramp	XSlope (%)	4.5
N/A	Flare Type LT	N/A	N/A	Flare	Type RT	N/A
N/A	Flare Slope LT (%)	N/A	N/A	Flare	Slope RT (%)	N/A
N/A	Flare Traversable LT?	N/A	N/A	Flare	Traversable RT?	N/A
N/A	Landing Length (in)	N/A	N/A	DWS	Provided?	N/A
N/A	Landing Width (in)	N/A	N/A	DWS	Contrast?	N/A
N/A	Landing Slope (%)	N/A	N/A	DWS	Length (in)	N/A
N/A	Landing X Slope (%)	N/A	N/A	DWS	Full Width?	N/A
N/A	Landing Curb? (Y/N)	N/A	N/A	DWS	Offset (in)	N/A
N/A	Shared Landing?	N/A				
N/A	Gutter Ponding?	N/A	N/A	Gutte	r Slope (%)	N/A
N/A	Gutter Lip Ht (in)	N/A	N/A	Gutte	r X Slope (%)	N/A
N/A	Painted X Walk1?	No	N/A	Paint	ed X Walk2?	No
	X Walk 1 Direction	To SW		X Wa	lk 2 Direction	To NE
N/A	X Walk 1 Width (in)	N/A	N/A	X Wa	lk 2 Width (in)	N/A
	X Walk 1 Slope (%)	0.1		X Wa	lk 2 Slope (%)	1.9
	X Walk 1 X Slope (%)	1.8		X Wa	lk 2 X Slope (%)	0.8

N/A	Ramp inside XWalk1?	N/A	N/A	Ram	inside XWalk2?	N/A
	Road Slope (%)	0.6	N/A	Clear	Space?	N/A
	Road X Slope (%)	0.6	N/A	Clear	Space to XWalk (in)	N/A
N/A	Any Obstructions?	N/A	N/A	Storn	n Grate/Utility Hazard?	N/A
	Obstruction Type			Storn	n Grate/Utility Type	
		N/A				N/A
			Yes	Surfa	ce Condition? (G/P)	Good

E 19TH ST Street 1 Name Stop Condition-Street 2 StopSign Street 2 Name **PEGRAM ST** Stop Condition-Street 1 StopSign Remove & Replace Curb Ramp With Two New Directional Ramps or Equivalent.
