Intersection ID: 9993436	Main Street: PLAZA_END_TC	Cross Street: MECKLENBURG_AV	Location:	NW
ADA ID: A054B0E9D4F0	Ramp Type: Perp	Initial Pass/Fail: Fail	Overall Compliance: No	Severity Score: 12.5

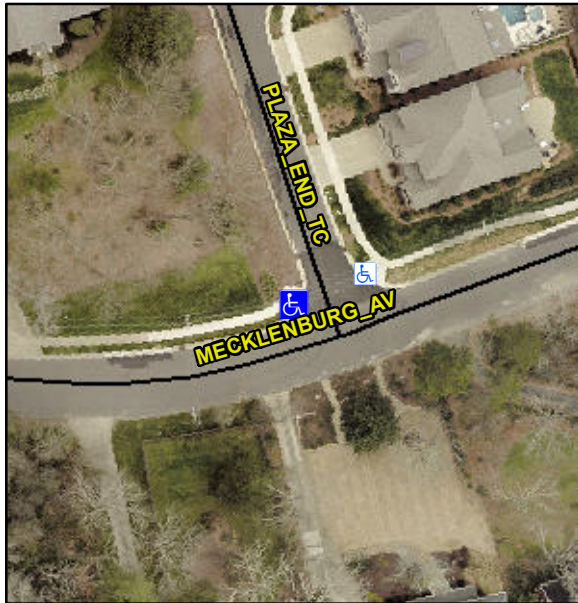
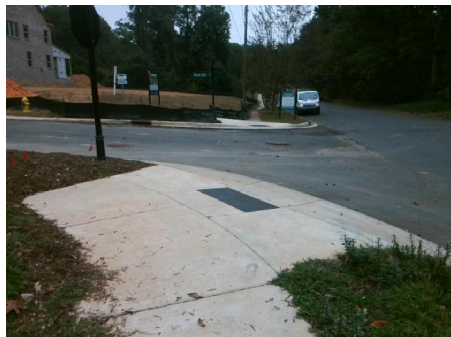
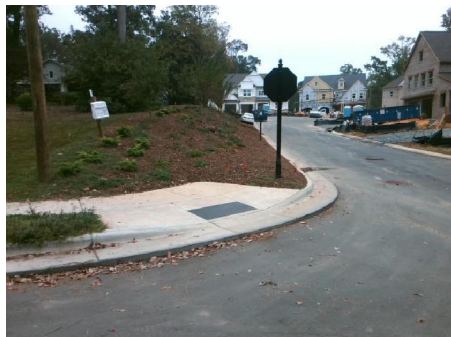
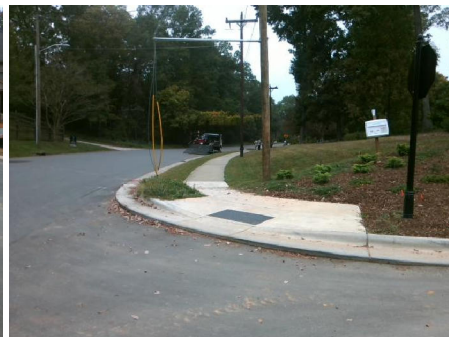
**Not Found, R304.2.2**

Possible Solutions:			Compliance	Description	Data	Compliance	Description	Data			
<b>Remove &amp; Replace Entire Ramp.</b>			N/A	Ramp Length (in)	49.5	No	Ramp Slope (%)	11.0			
			Yes	Ramp Width (in)	48.0	Yes	Ramp XSlope (%)	0.9			
			N/A	Flare Type LT	N/A	N/A	Flare Type RT	N/A			
			N/A	Flare Slope LT (%)	N/A	N/A	Flare Slope RT (%)	N/A			
			N/A	Flare Traversable LT?	N/A	N/A	Flare Traversable RT?	N/A			
			N/A	Landing Length (in)	N/A	N/A	DWS Provided?	N/A			
			N/A	Landing Width (in)	N/A	N/A	DWS Contrast?	N/A			
			N/A	Landing Slope (%)	N/A	N/A	DWS Length (in)	N/A			
			N/A	Landing X Slope (%)	N/A	N/A	DWS Full Width?	N/A			
			N/A	Landing Curb? (Y/N)	N/A	N/A	DWS Offset (in)	N/A			
			N/A	Shared Landing?	N/A						
			N/A	Gutter Ponding?	N/A	N/A	Gutter Slope (%)	N/A			
			N/A	Gutter Lip Ht (in)	3.0	N/A	Gutter X Slope (%)	N/A			
			N/A	Painted X Walk1?	No	N/A	Painted X Walk2?	N/A			
Surveyor Notes: <b>N/A</b>				X Walk 1 Direction	To E		X Walk 2 Direction	N/A

N/A	X Walk 1 Width (in)	N/A	N/A	X Walk 2 Width (in)	N/A			
				X Walk 1 Slope (%)	1.3		X Walk 2 Slope (%)	N/A			
				X Walk 1 X Slope (%)	3.6		X Walk 2 X Slope (%)	N/A			
			N/A	Ramp inside XWalk1?	N/A	N/A	Ramp inside XWalk2?	N/A			
				Road Slope (%)	N/A	N/A	Clear Space?	N/A			
				Road X Slope (%)	N/A	N/A	Clear Space to XWalk (in)	N/A			
			N/A	Any Obstructions?	N/A	N/A	Storm Grate/Utility Hazard?	N/A			
			Total Cost: \$ 1850.00				Obstruction Type			Storm Grate/Utility Type	
								N/A			N/A
								Yes	Surface Condition? (G/P)	Good

### Remove & Replace Entire Ramp.
