# Access Compliance Report

## Public Rights-of-Way

### (Curb Ramps)

Intersection ID: 14844	Main Street: DILWORTH_RD_WEST	Cross Street: EAST_BV	Location: SW
ADA ID: A0AAD6CFDFCC	Ramp Type: Directional1	Initial Pass/Fail: Pass	Overall Compliance: No
		Severity Score: 0.25

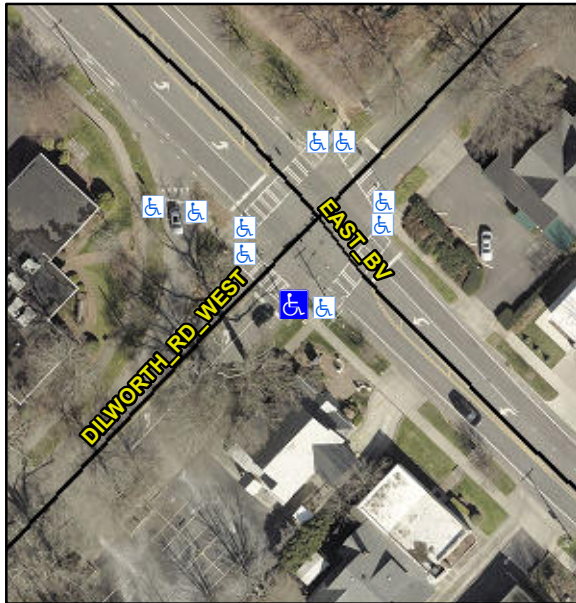
**N/A**

**R304.5.3**

Compliance	Description	Data	Compliance	Description	Data
N/A	Ramp Length (in)	40.0	N/A	Grade Break?	N/A
Yes	Ramp Width (in)	73.0	N/A	Grade Break Slope (%)	0.0
Yes	Ramp Slope (%)	3.5	N/A	Grade Break XSlope (%)	0.0
No	Ramp XSlope (%)	2.5			
N/A	Flare Type LT	N/A	N/A	Flare Type RT	N/A
N/A	Flare Slope LT (%)	N/A	N/A	Flare Slope RT (%)	N/A
N/A	Flare Traversable LT?	N/A	N/A	Flare Traversable RT?	N/A
Yes	Landing Length (in)	50.0	Yes	DWS Provided?	Yes
Yes	Landing Width (in)	73.0	Yes	DWS Contrast?	Yes
Yes	Landing Slope (%)	0.8	Yes	DWS Length (in)	25.5
No	Landing X Slope (%)	2.9	Yes	DWS Full Width?	Yes
N/A	Landing Curb? (Y/N)	No	Yes	DWS Offset LT (in)	0.0
N/A	Shared Landing?	No	Yes	DWS Offset RT (in)	8.0
Yes	Gutter Ponding?	No	Yes	Gutter Slope (%)	3.0
Yes	Gutter Lip Ht (in)	0.0	Yes	Gutter X Slope (%)	1.6
N/A	Painted X Walk1?	Yes		Road Slope (%)	4.2
	X Walk 1 Direction	To NW		Road X Slope (%)	0.9
	X Walk 1 Width (in)	107.0		Clear Space?	Yes

X Walk 1 Slope (%)	4.2	N/A	Clear Space to XWalk (in)	N/A
	X Walk 1 X Slope (%)	0.9	Yes	Storm Grate/Utility Hazard?	No
Yes	Ramp inside XWalk1?	Yes		Storm Grate/Utility Type	
Yes	Any Obstructions?	No			N/A
	Obstruction Type		Yes	Surface Condition? (G/P)	Good
			N/A	Curb Slope (%)	6.0

**Remove & Replace Entire Ramp.**

Total Cost: \$ **1600.00**
