# Access Compliance Report

## Public Rights-of-Way

### (Curb Ramps)

Intersection ID: 5525	Main Street: W_W_T_HARRIS_BV	Cross Street: MCCULLOUGH_DR	Location: E
ADA ID: A0BC69713C2F	Ramp Type: Perp	Initial Pass/Fail: Fail	Overall Compliance: No
Severity Score: 8.75			
Codes/Mitigation Info/Possible Solution		Field Measurements/Component Compliance

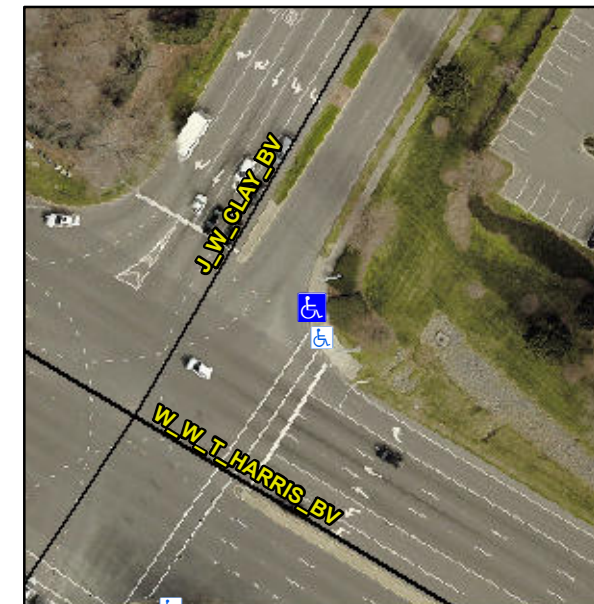
Compliance	Description	Data	Compliance	Description	Data
N/A	Ramp Length (in)	65.0	Yes	Ramp Slope (%)	7.0
No	Ramp Width (in)	47.5	Yes	Ramp XSlope (%)	1.7
N/A	Flare Type LT	N/A	N/A	Flare Type RT	N/A
N/A	Flare Slope LT (%)	N/A	N/A	Flare Slope RT (%)	N/A
N/A	Flare Traversable LT?	N/A	N/A	Flare Traversable RT?	N/A
N/A	Landing Length (in)	N/A	N/A	DWS Provided?	N/A
N/A	Landing Width (in)	N/A	N/A	DWS Contrast?	N/A
N/A	Landing Slope (%)	N/A	N/A	DWS Length (in)	N/A
N/A	Landing X Slope (%)	N/A	N/A	DWS Full Width?	N/A
N/A	Landing Curb? (Y/N)	N/A	N/A	DWS Offset (in)	N/A
N/A	Shared Landing?	N/A			
N/A	Gutter Ponding?	N/A	N/A	Gutter Slope (%)	N/A
N/A	Gutter Lip Ht (in)	0.5	N/A	Gutter X Slope (%)	N/A
N/A	Painted X Walk1?	No	N/A	Painted X Walk2?	N/A
	X Walk 1 Direction	To NW		X Walk 2 Direction	N/A
N/A	X Walk 1 Width (in)	N/A	N/A	X Walk 2 Width (in)	N/A
	X Walk 1 Slope (%)	3.3		X Walk 2 Slope (%)	N/A
	X Walk 1 X Slope (%)	1.7		X Walk 2 X Slope (%)	N/A

N/A	Ramp inside XWalk1?	N/A	N/A	Ramp inside XWalk2?	N/A
	Road Slope (%)	N/A	N/A	Clear Space?	N/A
	Road X Slope (%)	N/A	N/A	Clear Space to XWalk (in)	N/A
N/A	Any Obstructions?	N/A	N/A	Storm Grate/Utility Hazard?	N/A
	Obstruction Type			Storm Grate/Utility Type	
		N/A			N/A
			Yes	Surface Condition? (G/P)	Good

**Remove & Replace Entire Ramp.**

**R304.5.1**

Total Cost: \$ 1850.00
