Access Compliance Report

Public Rights-of-Way

(Curb Ramps)

Intersection ID: 9814	Main Street: CLIFTON_ST	Cross Street: PATTON_AV	Location:	N
ADA ID: A0C411A5351F	Ramp Type: Perp	Initial Pass/Fail: Fail	Overall Compliance: No	Severity Score: 8.75
Codes/Mitigation Info/Possible Solution		Field Measurements/Component Compliance

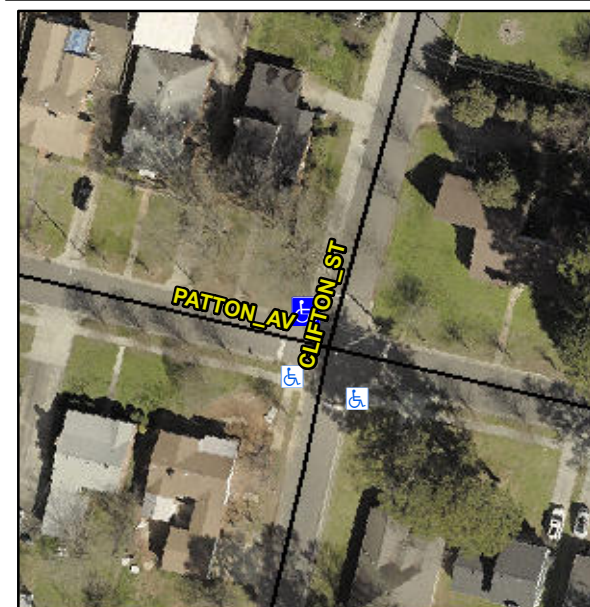
Compliance	Description	Data	Compliance	Description	Data
N/A	Ramp Length (in)	71.5	Yes	Ramp Slope (%)	6.9
No	Ramp Width (in)	46.5	Yes	Ramp XSlope (%)	1.9
N/A	Flare Type LT	N/A	N/A	Flare Type RT	N/A
N/A	Flare Slope LT (%)	N/A	N/A	Flare Slope RT (%)	N/A
N/A	Flare Traversable LT?	N/A	N/A	Flare Traversable RT?	N/A
N/A	Landing Length (in)	N/A	N/A	DWS Provided?	N/A
N/A	Landing Width (in)	N/A	N/A	DWS Contrast?	N/A
N/A	Landing Slope (%)	N/A	N/A	DWS Length (in)	N/A
N/A	Landing X Slope (%)	N/A	N/A	DWS Full Width?	N/A
N/A	Landing Curb? (Y/N)	N/A	N/A	DWS Offset (in)	N/A
N/A	Shared Landing?	N/A			
N/A	Gutter Ponding?	N/A	N/A	Gutter Slope (%)	N/A
N/A	Gutter Lip Ht (in)	N/A	N/A	Gutter X Slope (%)	N/A
N/A	Painted X Walk1?	No	N/A	Painted X Walk2?	N/A
	X Walk 1 Direction	To SW		X Walk 2 Direction	N/A
N/A	X Walk 1 Width (in)	N/A	N/A	X Walk 2 Width (in)	N/A
	X Walk 1 Slope (%)	0.3		X Walk 2 Slope (%)	N/A
	X Walk 1 X Slope (%)	0.5		X Walk 2 X Slope (%)	N/A

N/A	Ramp inside XWalk1?	N/A	N/A	Ramp inside XWalk2?	N/A
	Road Slope (%)	N/A	N/A	Clear Space?	N/A
	Road X Slope (%)	N/A	N/A	Clear Space to XWalk (in)	N/A
N/A	Any Obstructions?	N/A	N/A	Storm Grate/Utility Hazard?	N/A
	Obstruction Type			Storm Grate/Utility Type	
		N/A			N/A
			Yes	Surface Condition? (G/P)	Good

Possible Solutions:

Remove & Replace Entire Ramp.
