Access Compliance Report

Public Rights-of-Way

(Curb Ramps)

Intersection ID: 2927	Main Street: DOWNFIELD_WOOD_DR	Cross Street: RIDGEFIELD_DR	Location: NW
ADA ID: A0C6062CFC61	Ramp Type: Perp	Initial Pass/Fail: Fail	Overall Compliance: No
Codes/Mitigation Info/Possible Solution		Field Measurements/Component Compliance	
Severity Score: 8.75

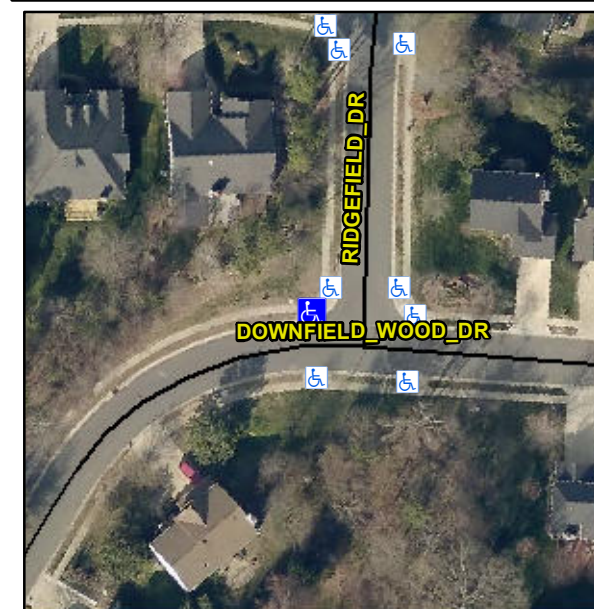
Compliance	Description	Data	Compliance	Description	Data
N/A	Ramp Length (in)	47.0	Yes	Ramp Slope (%)	8.1
No	Ramp Width (in)	40.5	Yes	Ramp XSlope (%)	1.1
N/A	Flare Type LT	N/A	N/A	Flare Type RT	N/A
N/A	Flare Slope LT (%)	N/A	N/A	Flare Slope RT (%)	N/A
N/A	Flare Traversable LT?	N/A	N/A	Flare Traversable RT?	N/A
N/A	Landing Length (in)	N/A	N/A	DWS Provided?	N/A
N/A	Landing Width (in)	N/A	N/A	DWS Contrast?	N/A
N/A	Landing Slope (%)	N/A	N/A	DWS Length (in)	N/A
N/A	Landing X Slope (%)	N/A	N/A	DWS Full Width?	N/A
N/A	Landing Curb? (Y/N)	N/A	N/A	DWS Offset (in)	N/A
N/A	Shared Landing?	N/A			
N/A	Gutter Ponding?	N/A	N/A	Gutter Slope (%)	N/A
N/A	Gutter Lip Ht (in)	N/A	N/A	Gutter X Slope (%)	N/A
N/A	Painted X Walk1?	No	N/A	Painted X Walk2?	N/A
	X Walk 1 Direction	To S		X Walk 2 Direction	N/A
N/A	X Walk 1 Width (in)	N/A	N/A	X Walk 2 Width (in)	N/A
	X Walk 1 Slope (%)	3.6		X Walk 2 Slope (%)	N/A
	X Walk 1 X Slope (%)	2.3		X Walk 2 X Slope (%)	N/A

N/A	Ramp inside XWalk1?	N/A	N/A	Ramp inside XWalk2?	N/A
	Road Slope (%)	N/A	N/A	Clear Space?	N/A
	Road X Slope (%)	N/A	N/A	Clear Space to XWalk (in)	N/A
N/A	Any Obstructions?	N/A	N/A	Storm Grate/Utility Hazard?	N/A
	Obstruction Type			Storm Grate/Utility Type	
		N/A			N/A
			Yes	Surface Condition? (G/P)	Good

Possible Solutions:

Remove & Replace Entire Ramp.

R304.5.1
