Access Compliance Report

Public Rights-of-Way

(Curb Ramps)

Intersection ID: 10003849	Main Street: DIXIE_RIVER_RD	Cross Street: NEW_FASHION_WY	Location: NW
ADA ID: A0DBE23C79BA	Ramp Type: Perp	Initial Pass/Fail: Fail	Overall Compliance: No
			Severity Score: 21.25

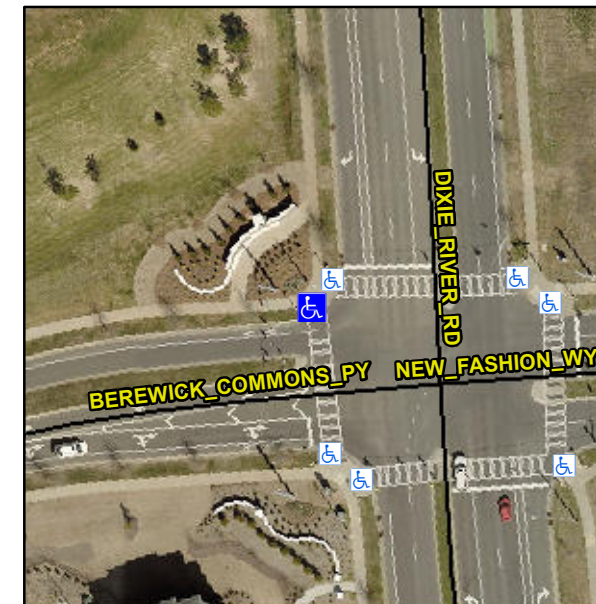
R304.5.1, R304.2.2

Compliance	Description	Data	Compliance	Description	Data
N/A	Ramp Length (in)	72.0	No	Ramp Slope (%)	8.7
No	Ramp Width (in)	46.0	Yes	Ramp XSlope (%)	1.3
N/A	Flare Type LT	N/A	N/A	Flare Type RT	N/A
N/A	Flare Slope LT (%)	N/A	N/A	Flare Slope RT (%)	N/A
N/A	Flare Traversable LT?	N/A	N/A	Flare Traversable RT?	N/A
N/A	Landing Length (in)	N/A	N/A	DWS Provided?	N/A
N/A	Landing Width (in)	N/A	N/A	DWS Contrast?	N/A
N/A	Landing Slope (%)	N/A	N/A	DWS Length (in)	N/A
N/A	Landing X Slope (%)	N/A	N/A	DWS Full Width?	N/A
N/A	Landing Curb? (Y/N)	N/A	N/A	DWS Offset (in)	N/A
N/A	Shared Landing?	N/A			
N/A	Gutter Ponding?	N/A	N/A	Gutter Slope (%)	N/A
N/A	Gutter Lip Ht (in)	N/A	N/A	Gutter X Slope (%)	N/A
N/A	Painted X Walk1?	Yes	N/A	Painted X Walk2?	N/A
	X Walk 1 Direction	To S		X Walk 2 Direction	N/A
N/A	X Walk 1 Width (in)	110.0	N/A	X Walk 2 Width (in)	N/A
	X Walk 1 Slope (%)	2.7		X Walk 2 Slope (%)	N/A
	X Walk 1 X Slope (%)	0.3		X Walk 2 X Slope (%)	N/A

N/A	Ramp inside XWalk1?	Yes	N/A	Ramp inside XWalk2?	N/A
	Road Slope (%)	N/A	N/A	Clear Space?	N/A
	Road X Slope (%)	N/A	N/A	Clear Space to XWalk (in)	N/A
N/A	Any Obstructions?	N/A	N/A	Storm Grate/Utility Hazard?	N/A
	Obstruction Type			Storm Grate/Utility Type	
		N/A			N/A
			Yes	Surface Condition? (G/P)	Good

Possible Solutions:

Remove & Replace Entire Ramp.

Total Cost: \$ 1850.00
