# Access Compliance Report

## Public Rights-of-Way

### (Curb Ramps)

Intersection ID: 25630	Main Street: BRIANTON_PL	Cross Street: STALLWORTH_DR	Location: E
ADA ID: A0E659ACF055	Ramp Type: BlendTrans1	Initial Pass/Fail: Fail	Overall Compliance: No
		Severity Score: 10

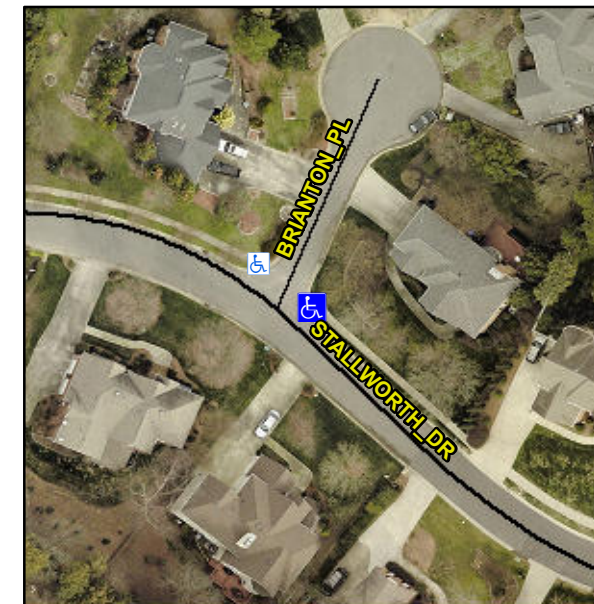
Compliance	Description	Data	Compliance	Description	Data
N/A	Ramp Length (in)	60.0	Yes	BlendTrans Slope (%)	4.8
No	Ramp Width (in)	47.0	No	BlendTrans XSlope (%)	5.0
N/A	Flare Type LT	N/A	N/A	Flare Type RT	N/A
N/A	Flare Slope LT (%)	N/A	N/A	Flare Slope RT (%)	N/A
N/A	Flare Traversable LT?	N/A	N/A	Flare Traversable RT?	N/A
N/A	Landing Length (in)	N/A	N/A	DWS Provided?	N/A
N/A	Landing Width (in)	N/A	N/A	DWS Contrast?	N/A
N/A	Landing Slope (%)	N/A	N/A	DWS Length (in)	N/A
N/A	Landing X Slope (%)	N/A	N/A	DWS Full Width?	N/A
N/A	Landing Curb? (Y/N)	N/A	N/A	DWS Offset (in)	N/A
N/A	Shared Landing?	N/A			
N/A	Gutter Ponding?	N/A	N/A	Gutter Slope (%)	N/A
N/A	Gutter Lip Ht (in)	N/A	N/A	Gutter X Slope (%)	N/A
N/A	Painted X Walk1?	No	N/A	Painted X Walk2?	No
	X Walk 1 Direction	To NW		X Walk 2 Direction	To SW
	X Walk 1 Width (in)	N/A		X Walk 2 Width (in)	N/A
	X Walk 1 Slope (%)	1.2		X Walk 2 Slope (%)	2.8
	X Walk 1 X Slope (%)	1.3		X Walk 2 X Slope (%)	2.2

N/A	Ramp inside XWalk1?	N/A	N/A	Ramp inside XWalk2?	N/A
	Road Slope (%)	2.7		Clear Space?	N/A
	Road X Slope (%)	0.4	N/A	Clear Space to XWalk (in)	N/A
N/A	Any Obstructions?	N/A	N/A	Storm Grate/Utility Hazard?	N/A
	Obstruction Type			Storm Grate/Utility Type	
		N/A			N/A
			Yes	Surface Condition? (G/P)	Good
			N/A	Curb Slope (%)	5.0

**Remove & Replace Curb Ramp With Two New Directional Ramps or Equivalent.**
