Access Compliance Report

Public Rights-of-Way

(Curb Ramps)

| Intersection ID: 50584 | Main Street: GREAT_LAUREL_RD | Cross Street: GRAND_FIR_RD | Location: SW |

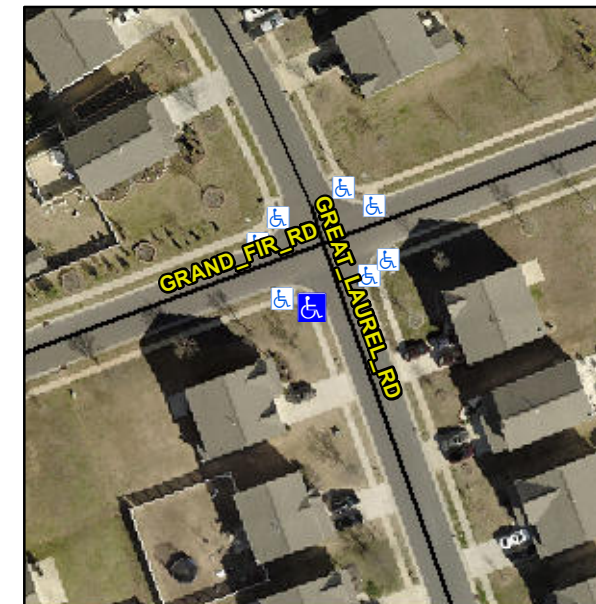
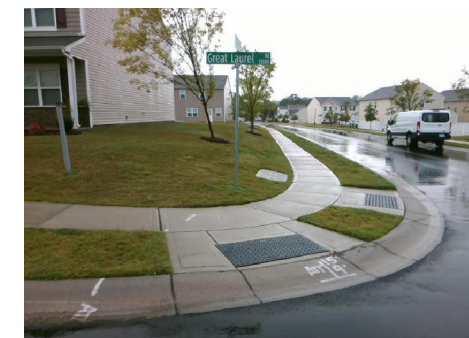
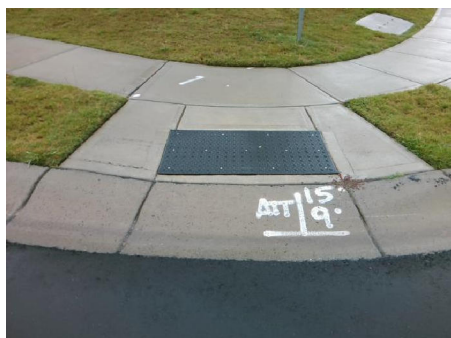
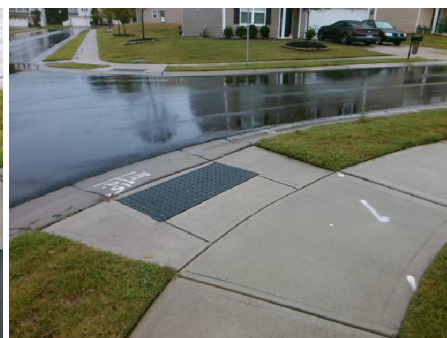
| ADA ID: A0EBD53314A4 | Ramp Type: Perp | Initial Pass/Fail: Fail | Overall Compliance: No |

Not Found, R304.5.1, R304.5.3

| Compliance | Description | Data | Compliance | Description | Data |
|---|---|---|---|---|---|
| N/A | Ramp Length (in) | 48.5 | Yes | Ramp Slope (%) | 5.1 |
| No | Ramp Width (in) | 42.5 | No | Ramp XSlope (%) | 3.8 |

Remove & Replace Entire Ramp.
