Access Compliance Report

Public Rights-of-Way

(Curb Ramps)

Intersection ID: 25377	Main Street: BRIGMORE_DR	Cross Street: CARMEL_RD	Location: E
ADA ID: A0FF9301EA1D	Ramp Type: PerpDiag	Initial Pass/Fail: Fail	Overall Compliance: No
Severity Score: 21.25			
Codes/Mitigation Info/Possible Solution		Field Measurements/Component Compliance

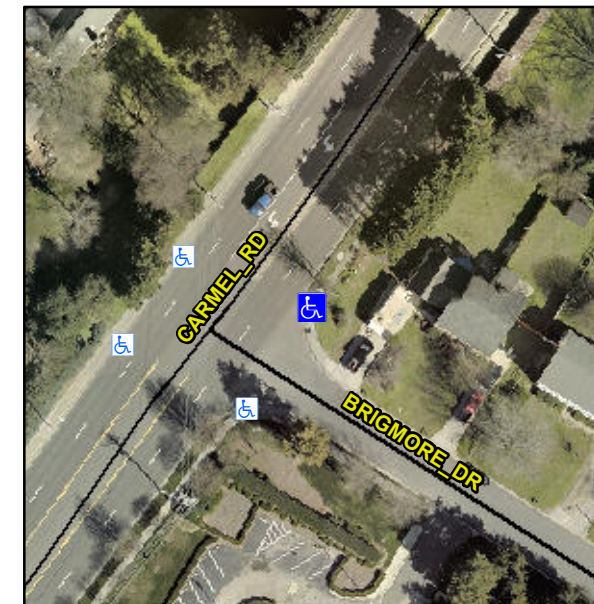
R304.5.1, R304.2.2

Compliance	Description	Data	Compliance	Description	Data
N/A	Ramp Length (in)	58.0	No	Ramp Slope (%)	9.6
No	Ramp Width (in)	45.0	Yes	Ramp XSlope (%)	0.1
N/A	Flare Type LT	N/A	N/A	Flare Type RT	N/A
N/A	Flare Slope LT (%)	N/A	N/A	Flare Slope RT (%)	N/A
N/A	Flare Traversable LT?	N/A	N/A	Flare Traversable RT?	N/A
N/A	Landing Length (in)	N/A	N/A	DWS Provided?	N/A
N/A	Landing Width (in)	N/A	N/A	DWS Contrast?	N/A
N/A	Landing Slope (%)	N/A	N/A	DWS Length (in)	N/A
N/A	Landing X Slope (%)	N/A	N/A	DWS Full Width?	N/A
N/A	Landing Curb? (Y/N)	N/A	N/A	DWS Offset (in)	N/A
N/A	Shared Landing?	N/A			
N/A	Gutter Ponding?	N/A	N/A	Gutter Slope (%)	N/A
N/A	Gutter Lip Ht (in)	N/A	N/A	Gutter X Slope (%)	N/A
N/A	Painted X Walk1?	No	N/A	Painted X Walk2?	No
	X Walk 1 Direction	To NW		X Walk 2 Direction	To SW
N/A	X Walk 1 Width (in)	N/A	N/A	X Walk 2 Width (in)	N/A
	X Walk 1 Slope (%)	1.6		X Walk 2 Slope (%)	2.0
	X Walk 1 X Slope (%)	2.3		X Walk 2 X Slope (%)	1.4

N/A	Ramp inside XWalk1?	N/A	N/A	Ramp inside XWalk2?	N/A
	Road Slope (%)	0.1	N/A	Clear Space?	N/A
	Road X Slope (%)	1.8	N/A	Clear Space to XWalk (in)	N/A
N/A	Any Obstructions?	N/A	N/A	Storm Grate/Utility Hazard?	N/A
	Obstruction Type			Storm Grate/Utility Type	
		N/A			N/A
		Yes		Surface Condition? (G/P)	Good

Remove & Replace Curb Ramp With Two New Directional Ramps or Equivalent.
