Access Compliance Report

Public Rights-of-Way

(Curb Ramps)

Intersection ID: 10024336	Main Street: CREEKRIDGE_RD	Cross Street: N/A	Location: NE
ADA ID: A1087C3A8E51	Ramp Type: Directional1	Initial Pass/Fail: Fail	Overall Compliance: No
		Severity Score: 12.5

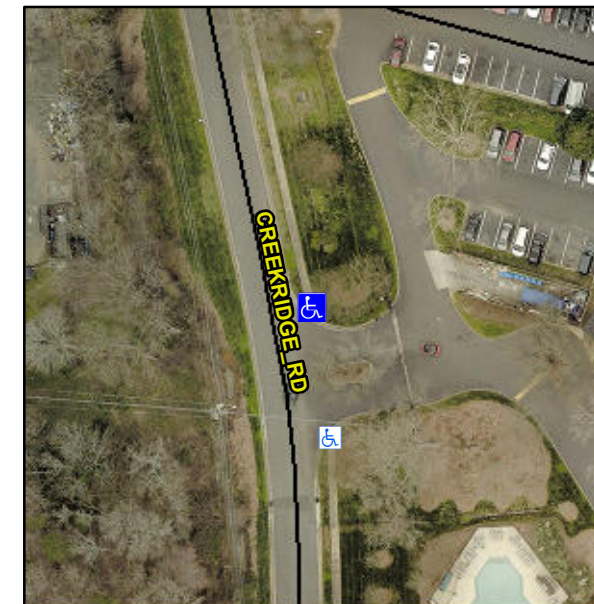
Compliance	Description	Data	Compliance	Description	Data
N/A	Ramp Length (in)	83.0	N/A	Grade Break?	N/A
Yes	Ramp Width (in)	48.0	N/A	Grade Break Slope (%)	0.0
Yes	Ramp Slope (%)	3.1	N/A	Grade Break XSlope (%)	0.0
No	Ramp XSlope (%)	5.3			
N/A	Flare Type LT	N/A	N/A	Flare Type RT	N/A
N/A	Flare Slope LT (%)	N/A	N/A	Flare Slope RT (%)	0.0
N/A	Flare Traversable LT?	N/A	N/A	Flare Traversable RT?	N/A
N/A	Landing Length (in)	0.0	N/A	DWS Provided?	N/A
N/A	Landing Width (in)	0.0	N/A	DWS Contrast?	N/A
N/A	Landing Slope (%)	0.0	N/A	DWS Length (in)	N/A
N/A	Landing X Slope (%)	0.0	N/A	DWS Full Width?	N/A
N/A	Landing Curb? (Y/N)	N/A	N/A	DWS Offset LT (in)	N/A
N/A	Shared Landing?	N/A	N/A	DWS Offset RT (in)	N/A
N/A	Gutter Ponding?	0.0	N/A	Gutter Slope (%)	N/A
N/A	Gutter Lip Ht (in)	0.0	N/A	Gutter X Slope (%)	N/A
N/A	Painted X Walk1?	No		Road Slope (%)	0.2
	X Walk 1 Direction	To SW		Road X Slope (%)	1.9
	X Walk 1 Width (in)	N/A		Clear Space?	N/A

X Walk 1 Slope (%)	0.2	N/A	Clear Space to XWalk (in)	N/A
	X Walk 1 X Slope (%)	1.9	N/A	Storm Grate/Utility Hazard?	N/A
N/A	Ramp inside XWalk1?	N/A		Storm Grate/Utility Type	
N/A	Any Obstructions?	N/A			N/A
	Obstruction Type		Yes	Surface Condition? (G/P)	Good
			N/A	Curb Slope (%)	6.4

Possible Solutions:

Remove & Replace Entire Ramp.

Total Cost: \$ 1600.00
