Access Compliance Report

Public Rights-of-Way

(Curb Ramps)

Intersection ID: 4012	Main Street: CLINGMAN_LN	Cross Street: WRANGELL_LN	Location: NE
ADA ID: A10A9BF9A509	Ramp Type: BlendTrans1	Initial Pass/Fail: Fail	Overall Compliance: No
			Severity Score: 21.25

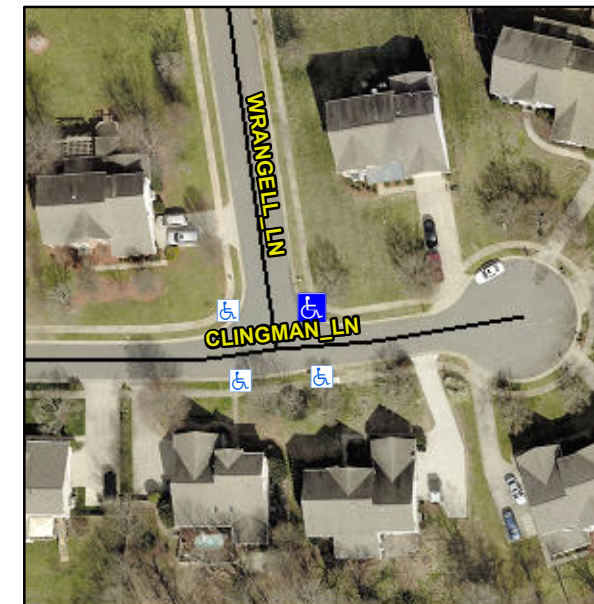
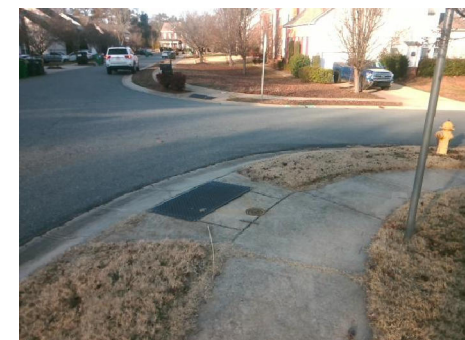
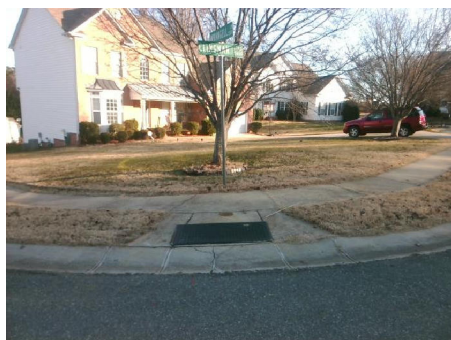
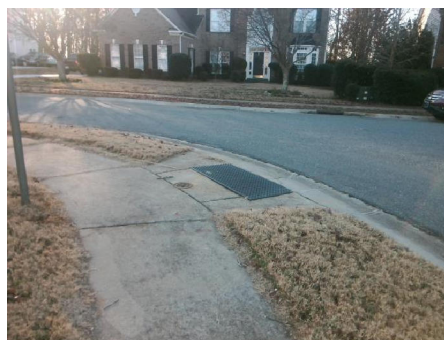
Not Found, R304.5.1, R304.5.3

Compliance	Description	Data	Compliance	Description	Data
N/A	Ramp Length (in)	47.0	Yes	BlendTrans Slope (%)	3.3
No	Ramp Width (in)	39.0	No	BlendTrans XSlope (%)	5.2
N/A	Flare Type LT	N/A	N/A	Flare Type RT	N/A
N/A	Flare Slope LT (%)	N/A	N/A	Flare Slope RT (%)	N/A
N/A	Flare Traversable LT?	N/A	N/A	Flare Traversable RT?	N/A
N/A	Landing Length (in)	N/A	N/A	DWS Provided?	N/A
N/A	Landing Width (in)	N/A	N/A	DWS Contrast?	N/A
N/A	Landing Slope (%)	N/A	N/A	DWS Length (in)	N/A
N/A	Landing X Slope (%)	N/A	N/A	DWS Full Width?	N/A
N/A	Landing Curb? (Y/N)	N/A	N/A	DWS Offset (in)	N/A
N/A	Shared Landing?	N/A			
N/A	Gutter Ponding?	N/A	N/A	Gutter Slope (%)	N/A
N/A	Gutter Lip Ht (in)	N/A	N/A	Gutter X Slope (%)	N/A
N/A	Painted X Walk1?	No	N/A	Painted X Walk2?	No
	X Walk 1 Direction	To W		X Walk 2 Direction	To S
	X Walk 1 Width (in)	N/A		X Walk 2 Width (in)	N/A
	X Walk 1 Slope (%)	1.8		X Walk 2 Slope (%)	3.9
	X Walk 1 X Slope (%)	5.6		X Walk 2 X Slope (%)	1.3

N/A	Ramp inside XWalk1?	N/A	N/A	Ramp inside XWalk2?	N/A
	Road Slope (%)	4.9		Clear Space?	N/A
	Road X Slope (%)	0.5	N/A	Clear Space to XWalk (in)	N/A
N/A	Any Obstructions?	N/A	N/A	Storm Grate/Utility Hazard?	N/A
	Obstruction Type			Storm Grate/Utility Type	
		N/A			N/A
			Yes	Surface Condition? (G/P)	Good
			No	Curb Slope (%)	6.5

Remove & Replace Curb Ramp With Two New Directional Ramps or Equivalent.

Total Cost: \$ 3200.00
