Access Compliance Report Public Rights-of-Way (Curb Ramps)

Intersection ID: 10033270 Main Street: OAKDALE_GREEN_DR Cross Street: N/A Location: NW

ADA ID: A10D83F755AC Ramp Type: Perp Initial Pass/Fail: Fail Overall Compliance: No Severity Score: 25

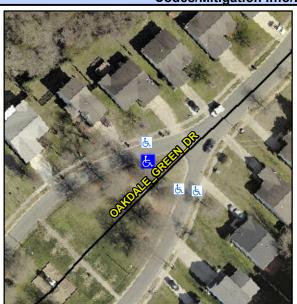
Compliance Description [Data	Comp	liance Description	Data
N/A	Ramp Length (in)	208.0	Yes	Ramp Slope (%)	13.2
Yes	Ramp Width (in)	60.0	Yes	Ramp XSlope (%)	0.6
N/A	Flare Type LT	N/A	N/A	Flare Type RT	N/A
N/A	Flare Slope LT (%)	N/A	N/A	Flare Slope RT (%)	N/A
N/A	Flare Traversable LT?	N/A	N/A	Flare Traversable RT?	N/A
N/A	Landing Length (in)	N/A	N/A	DWS Provided?	N/A
N/A	Landing Width (in)	N/A	N/A	DWS Contrast?	N/A
N/A	Landing Slope (%)	N/A	N/A	DWS Length (in)	N/A
N/A	Landing X Slope (%)	N/A	N/A	DWS Full Width?	N/A
N/A	Landing Curb? (Y/N)	N/A	N/A	DWS Offset (in)	N/A
N/A	Shared Landing?	N/A			
N/A	Gutter Ponding?	N/A	N/A	Gutter Slope (%)	N/A
N/A	Gutter Lip Ht (in)	N/A	N/A	Gutter X Slope (%)	N/A
N/A	Painted X Walk1?	No	N/A	Painted X Walk2?	N/A
	X Walk 1 Direction	To NE		X Walk 2 Direction	N/A
N/A	X Walk 1 Width (in)	N/A	N/A	X Walk 2 Width (in)	N/A
	X Walk 1 Slope (%)	1.2		X Walk 2 Slope (%)	N/A
	X Walk 1 X Slope (%)	2.4		X Walk 2 X Slope (%)	N/A

N/A	Ramp inside XWalk1?	N/A	N/A	Ramp inside XWalk2?	N/A
	Road Slope (%)	N/A	N/A	Clear Space?	N/A
	Road X Slope (%)	N/A	N/A	Clear Space to XWalk (in)	N/A
N/A	Any Obstructions?	N/A	N/A	Storm Grate/Utility Hazard?	N/A
	Obstruction Type		l	Storm Grate/Utility Type	
		N/A			N/A

Remove & Replace Entire Ramp.
