Access Compliance Report

Public Rights-of-Way

(Curb Ramps)

Intersection ID: 8067	Main Street: OLD_CONCORD_RD	Cross Street: BRANCH_HILL_CR	Location:	N
ADA ID: A1313F92EC46	Ramp Type: Perp	Initial Pass/Fail: Fail	Overall Compliance: No	Severity Score: 1.25

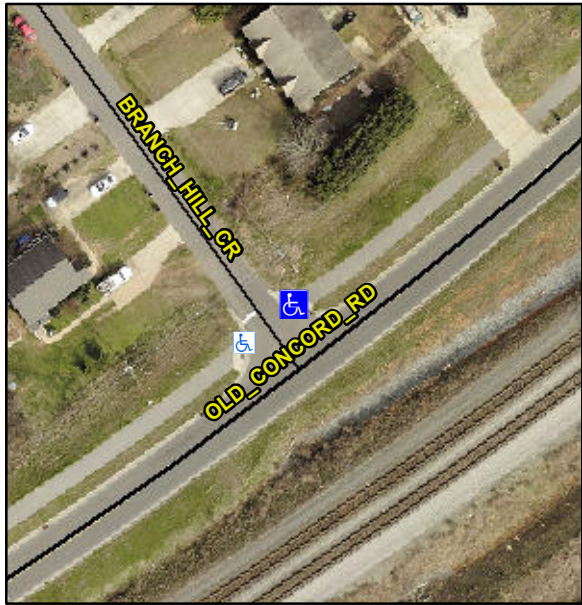
Possible Solutions:		Compliance	Description	Data	Compliance	Description	Data
	Remove & Replace Entire Ramp.		N/A	Ramp Length (in)	52.0	Yes	Ramp Slope (%)	6.7
			Yes	Ramp Width (in)	59.0	No	Ramp XSlope (%)	4.2
			N/A	Flare Type LT	N/A	N/A	Flare Type RT	N/A
			N/A	Flare Slope LT (%)	N/A	N/A	Flare Slope RT (%)	N/A
			N/A	Flare Traversable LT?	N/A	N/A	Flare Traversable RT?	N/A
			N/A	Landing Length (in)	N/A	N/A	DWS Provided?	N/A
			N/A	Landing Width (in)	N/A	N/A	DWS Contrast?	N/A
			N/A	Landing Slope (%)	N/A	N/A	DWS Length (in)	N/A
			N/A	Landing X Slope (%)	N/A	N/A	DWS Full Width?	N/A
Surveyor Notes:			N/A	Landing Curb? (Y/N)	N/A	N/A	DWS Offset (in)	N/A
N/A			N/A	Shared Landing?	N/A			
PROW/ADA:			N/A	Gutter Ponding?	N/A	N/A	Gutter Slope (%)	N/A
Not Found, R304.5.3			N/A	Gutter Lip Ht (in)	N/A	N/A	Gutter X Slope (%)	N/A
