# Access Compliance Report

## Public Rights-of-Way

### (Curb Ramps)

Intersection ID: N/A	Main Street: SOUTHMORE_DR	Cross Street: HOUSTON_FIELD_CT	Location: SE
ADA ID: A136EF69347A	Ramp Type: Directional1	Initial Pass/Fail: Fail	Overall Compliance: No
		Severity Score: 25

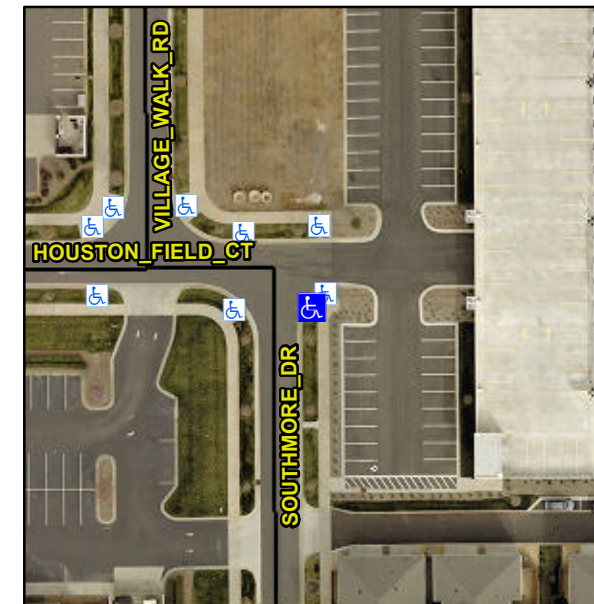
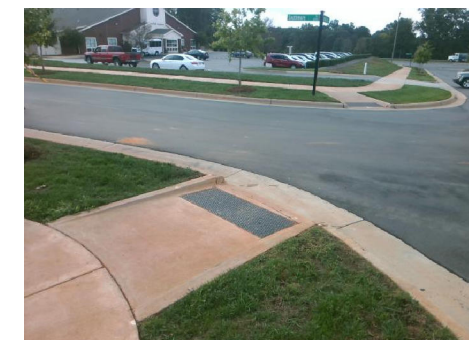
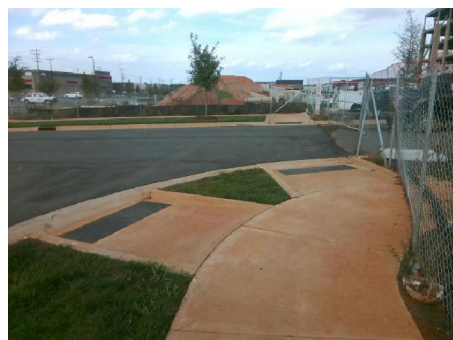
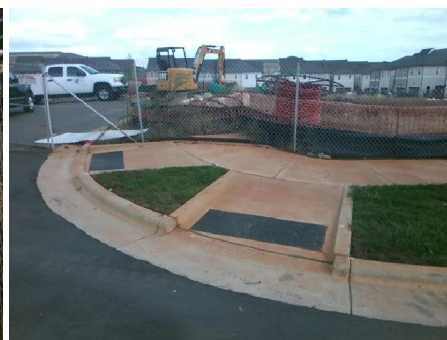
**R304.2.2, R304.5.3**

Compliance	Description	Data	Compliance	Description	Data
N/A	Ramp Length (in)	80.0	N/A	Grade Break?	N/A
Yes	Ramp Width (in)	70.0	N/A	Grade Break Slope (%)	0.0
No	Ramp Slope (%)	8.6	N/A	Grade Break XSlope (%)	0.0
No	Ramp XSlope (%)	5.4			
N/A	Flare Type LT	N/A	N/A	Flare Type RT	N/A
N/A	Flare Slope LT (%)	N/A	N/A	Flare Slope RT (%)	0.0
N/A	Flare Traversable LT?	N/A	N/A	Flare Traversable RT?	N/A
N/A	Landing Length (in)	0.0	N/A	DWS Provided?	N/A
N/A	Landing Width (in)	0.0	N/A	DWS Contrast?	N/A
N/A	Landing Slope (%)	0.0	N/A	DWS Length (in)	N/A
N/A	Landing X Slope (%)	0.0	N/A	DWS Full Width?	N/A
N/A	Landing Curb? (Y/N)	N/A	N/A	DWS Offset LT (in)	N/A
N/A	Shared Landing?	N/A	N/A	DWS Offset RT (in)	N/A
N/A	Gutter Ponding?	0.0	N/A	Gutter Slope (%)	N/A
N/A	Gutter Lip Ht (in)	0.0	N/A	Gutter X Slope (%)	N/A
N/A	Painted X Walk1?	No		Road Slope (%)	1.4
	X Walk 1 Direction	To W		Road X Slope (%)	1.0
	X Walk 1 Width (in)	N/A		Clear Space?	N/A

X Walk 1 Slope (%)	1.4	N/A	Clear Space to XWalk (in)	N/A
	X Walk 1 X Slope (%)	1.0	N/A	Storm Grate/Utility Hazard?	N/A
N/A	Ramp inside XWalk1?	N/A		Storm Grate/Utility Type	
N/A	Any Obstructions?	N/A			N/A
	Obstruction Type		Yes	Surface Condition? (G/P)	Good
			N/A	Curb Slope (%)	11.2

**Remove & Replace Entire Ramp.**
