Access Compliance Report

Public Rights-of-Way

(Curb Ramps)

Intersection ID: 15013	Main Street: E_WORTHINGTON_AV	Cross Street: EWING_AV	Location: E
ADA ID: A140585D83CF	Ramp Type: Perp	Initial Pass/Fail: Fail	Overall Compliance: No
			Severity Score: 21.25

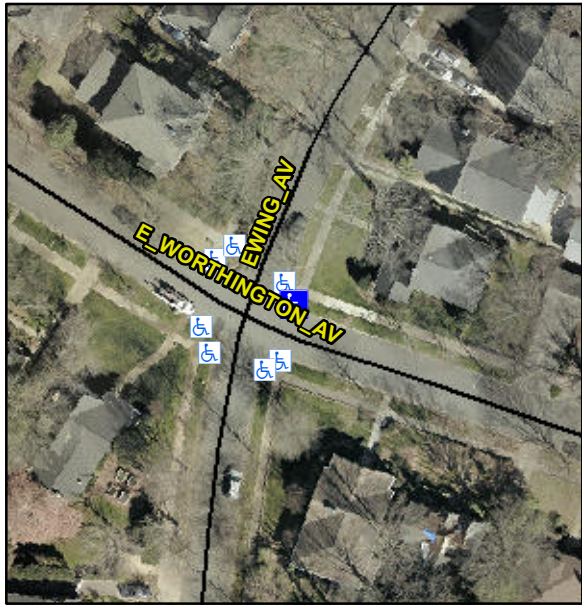
Possible Solutions:		Compliance	Description	Data	Compliance	Description	Data
	Remove & Replace Entire Ramp.		N/A	Ramp Length (in)	80.0	No	Ramp Slope (%)	8.7
			No	Ramp Width (in)	36.0	Yes	Ramp XSlope (%)	1.3
			N/A	Flare Type LT	N/A	N/A	Flare Type RT	N/A
			N/A	Flare Slope LT (%)	N/A	N/A	Flare Slope RT (%)	N/A
			N/A	Flare Traversable LT?	N/A	N/A	Flare Traversable RT?	N/A
			N/A	Landing Length (in)	N/A	N/A	DWS Provided?	N/A
			N/A	Landing Width (in)	N/A	N/A	DWS Contrast?	N/A
			N/A	Landing Slope (%)	N/A	N/A	DWS Length (in)	N/A
			N/A	Landing X Slope (%)	N/A	N/A	DWS Full Width?	N/A
Surveyor Notes:			N/A	Landing Curb? (Y/N)	N/A	N/A	DWS Offset (in)	N/A
N/A			N/A	Shared Landing?	N/A			
PROW/ADA:			N/A	Gutter Ponding?	N/A	N/A	Gutter Slope (%)	N/A
Not Found, R304.5.1, R304.2.2			N/A	Gutter Lip Ht (in)	N/A	N/A	Gutter X Slope (%)	N/A

N/A	Painted X Walk1?	No	N/A	Painted X Walk2?	N/A
				X Walk 1 Direction	To SW		X Walk 2 Direction	N/A
			N/A	X Walk 1 Width (in)	N/A	N/A	X Walk 2 Width (in)	N/A
				X Walk 1 Slope (%)	5.5		X Walk 2 Slope (%)	N/A
				X Walk 1 X Slope (%)	3.2		X Walk 2 X Slope (%)	N/A
			N/A	Ramp inside XWalk1?	N/A	N/A	Ramp inside XWalk2?	N/A
				Road Slope (%)	N/A	N/A	Clear Space?	N/A
				Road X Slope (%)	N/A	N/A	Clear Space to XWalk (in)	N/A
			N/A	Any Obstructions?	N/A	N/A	Storm Grate/Utility Hazard?	N/A
				Obstruction Type			Storm Grate/Utility Type	
					N/A			N/A
						Yes	Surface Condition? (G/P)	Good
Street 1 Name			E WORTHINGTON AV					
Stop Condition-Street 2			None					
Street 2 Name			N/A					
Stop Condition-Street 1			N/A					
Total Cost:			\$ 1850.00
