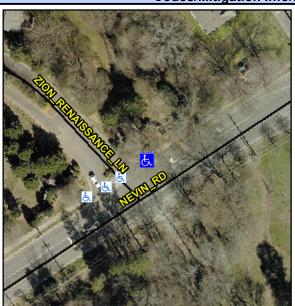
Intersection ID: 5879Main Street:NEVIN_RDCross Street:ZION_RENAISSANCE_LNLocation:NEADA ID: A1569B0FCBAFRamp Type:PerpInitial Pass/Fail:FailOverall Compliance:NoSeverity Score:10

Field Measurements/Component Compliance								
Comp	Compliance Description		Comp	liance Description	Data			
N/A	Ramp Length (in)	55.5	Yes	Ramp Slope (%)	7.5			
No	Ramp Width (in)	47.0	Yes	Ramp XSlope (%)	2.2			
N/A	Flare Type LT	N/A	N/A	Flare Type RT	N/A			
N/A	Flare Slope LT (%)	N/A	N/A	Flare Slope RT (%)	N/A			
N/A	Flare Traversable LT?	N/A	N/A	Flare Traversable RT?	N/A			
N/A	Landing Length (in)	N/A	N/A	DWS Provided?	N/A			
N/A	Landing Width (in)	N/A	N/A	DWS Contrast?	N/A			
N/A	Landing Slope (%)	N/A	N/A	DWS Length (in)	N/A			
N/A	Landing X Slope (%)	N/A	N/A	DWS Full Width?	N/A			
N/A	Landing Curb? (Y/N)	N/A	N/A	DWS Offset (in)	N/A			
N/A	Shared Landing?	N/A						
N/A	Gutter Ponding?	N/A	N/A	Gutter Slope (%)	N/A			
N/A	Gutter Lip Ht (in)	N/A	N/A	Gutter X Slope (%)	N/A			
N/A	Painted X Walk1?	No	N/A	Painted X Walk2?	N/A			
	X Walk 1 Direction	To SW		X Walk 2 Direction	N/A			
N/A	X Walk 1 Width (in)	N/A	N/A	X Walk 2 Width (in)	N/A

X Walk 1 Slope (%)	0.3		X Walk 2 Slope (%)	N/A			
	X Walk 1 X Slope (%)	3.0		X Walk 2 X Slope (%)	N/A			
N/A	Ramp inside XWalk1?	N/A	N/A	Ramp inside XWalk2?	N/A			
	Road Slope (%)	N/A	N/A	Clear Space?	N/A			
	Road X Slope (%)	N/A	N/A	Clear Space to XWalk (in)	N/A			
N/A	Any Obstructions?	N/A	N/A	Storm Grate/Utility Hazard?	N/A			
	Obstruction Type			Storm Grate/Utility Type				
		N/A			N/A			
			Yes	Surface Condition? (G/P)	Good			
Strandy and

4		
1	Possible Solutions:	Co
6	Remove & Replace Entire Ramp.	N/A
-		No
5		N/A
WILL CO.		N/A
1		N/A
		N/A
ā	Surveyor Notes:	N/A
	N/A	N/A
-		N/A
		N/A
		N/A
1	PROW/ADA:	N/A
	Not Found, R304.5.1	N/A
The same of	,	N/A
į		N/A
