# Access Compliance Report

## Public Rights-of-Way

### (Curb Ramps)

Intersection ID: N/A	Main Street: INVERNESS_BAY_RD	Cross Street: PERTH_MOOR_RD	Location: SW
ADA ID: A15D36B1BBAF	Ramp Type: Perp	Initial Pass/Fail: Fail	Overall Compliance: No
Codes/Mitigation Info/Possible Solution		Field Measurements/Component Compliance	
Severity Score: 25

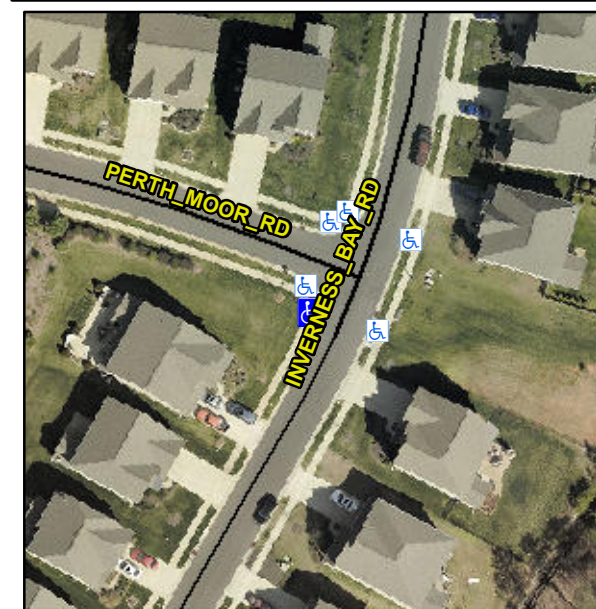
**Not Found, R304.2.2, R304.5.3**

Compliance	Description	Data	Compliance	Description	Data
N/A	Ramp Length (in)	47.0	No	Ramp Slope (%)	11.9
Yes	Ramp Width (in)	48.0	No	Ramp XSlope (%)	5.7
N/A	Flare Type LT	N/A	N/A	Flare Type RT	N/A
N/A	Flare Slope LT (%)	N/A	N/A	Flare Slope RT (%)	N/A
N/A	Flare Traversable LT?	N/A	N/A	Flare Traversable RT?	N/A
N/A	Landing Length (in)	N/A	N/A	DWS Provided?	N/A
N/A	Landing Width (in)	N/A	N/A	DWS Contrast?	N/A
N/A	Landing Slope (%)	N/A	N/A	DWS Length (in)	N/A
N/A	Landing X Slope (%)	N/A	N/A	DWS Full Width?	N/A
N/A	Landing Curb? (Y/N)	N/A	N/A	DWS Offset (in)	N/A
N/A	Shared Landing?	N/A			
N/A	Gutter Ponding?	N/A	N/A	Gutter Slope (%)	N/A
N/A	Gutter Lip Ht (in)	1.5	N/A	Gutter X Slope (%)	N/A
N/A	Painted X Walk1?	No	N/A	Painted X Walk2?	N/A
	X Walk 1 Direction	To SE		X Walk 2 Direction	N/A
N/A	X Walk 1 Width (in)	N/A	N/A	X Walk 2 Width (in)	N/A
	X Walk 1 Slope (%)	3.3		X Walk 2 Slope (%)	N/A
	X Walk 1 X Slope (%)	4.8		X Walk 2 X Slope (%)	N/A

N/A	Ramp inside XWalk1?	N/A	N/A	Ramp inside XWalk2?	N/A
	Road Slope (%)	N/A	N/A	Clear Space?	N/A
	Road X Slope (%)	N/A	N/A	Clear Space to XWalk (in)	N/A
N/A	Any Obstructions?	N/A	N/A	Storm Grate/Utility Hazard?	N/A
	Obstruction Type			Storm Grate/Utility Type	
		N/A			N/A
			Yes	Surface Condition? (G/P)	Good

**Remove & Replace Entire Ramp.**

Total Cost: \$ 1850.00
