# Access Compliance Report

## Public Rights-of-Way

### (Curb Ramps)

Intersection ID: 7901	Main Street: GLENMOOR_DR	Cross Street: LITTLE_ROCK_RD	Location: S
ADA ID: A15F7DFDDDEF	Ramp Type: Perp	Initial Pass/Fail: Fail	Overall Compliance: No
Severity Score: 8.75			
Codes/Mitigation Info/Possible Solution		Field Measurements/Component Compliance

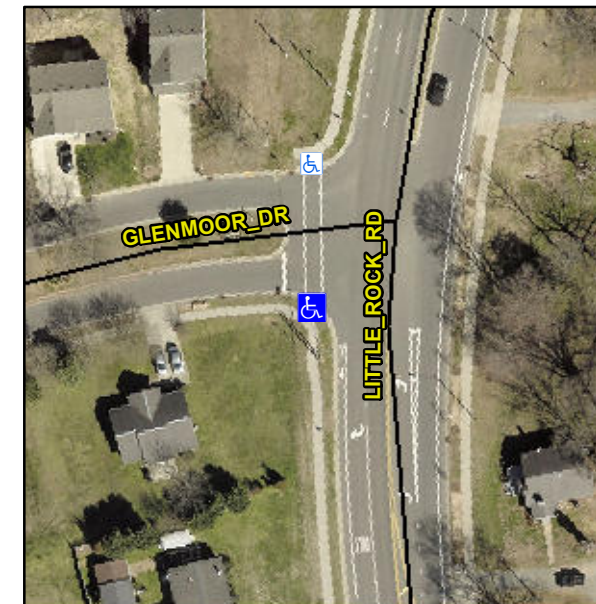
**Not Found, R304.5.1**

Compliance	Description	Data	Compliance	Description	Data
N/A	Ramp Length (in)	81.0	Yes	Ramp Slope (%)	7.6
No	Ramp Width (in)	47.0	Yes	Ramp XSlope (%)	0.5
N/A	Flare Type LT	N/A	N/A	Flare Type RT	N/A
N/A	Flare Slope LT (%)	N/A	N/A	Flare Slope RT (%)	N/A
N/A	Flare Traversable LT?	N/A	N/A	Flare Traversable RT?	N/A
N/A	Landing Length (in)	N/A	N/A	DWS Provided?	N/A
N/A	Landing Width (in)	N/A	N/A	DWS Contrast?	N/A
N/A	Landing Slope (%)	N/A	N/A	DWS Length (in)	N/A
N/A	Landing X Slope (%)	N/A	N/A	DWS Full Width?	N/A
N/A	Landing Curb? (Y/N)	N/A	N/A	DWS Offset (in)	N/A
N/A	Shared Landing?	N/A			
N/A	Gutter Ponding?	N/A	N/A	Gutter Slope (%)	N/A
N/A	Gutter Lip Ht (in)	N/A	N/A	Gutter X Slope (%)	N/A
N/A	Painted X Walk1?	Yes	N/A	Painted X Walk2?	N/A
	X Walk 1 Direction	To N		X Walk 2 Direction	N/A
N/A	X Walk 1 Width (in)	97.5	N/A	X Walk 2 Width (in)	N/A
	X Walk 1 Slope (%)	1.6		X Walk 2 Slope (%)	N/A
	X Walk 1 X Slope (%)	0.9		X Walk 2 X Slope (%)	N/A

N/A	Ramp inside XWalk1?	Yes	N/A	Ramp inside XWalk2?	N/A
	Road Slope (%)	N/A	N/A	Clear Space?	N/A
	Road X Slope (%)	N/A	N/A	Clear Space to XWalk (in)	N/A
N/A	Any Obstructions?	N/A	N/A	Storm Grate/Utility Hazard?	N/A
	Obstruction Type			Storm Grate/Utility Type	
		N/A			N/A
		Yes		Surface Condition? (G/P)	Good

**Remove & Replace Entire Ramp.**

Total Cost: \$ 1850.00
