Access Compliance Report

Public Rights-of-Way

(Curb Ramps)

Intersection ID: 15827	Main Street: CLANTON_RD	Cross Street: PELTON_ST	Location: NW
ADA ID: A172E6B6F49C	Ramp Type: PerpDiag	Initial Pass/Fail: Fail	Overall Compliance: No
		Severity Score: 12.5

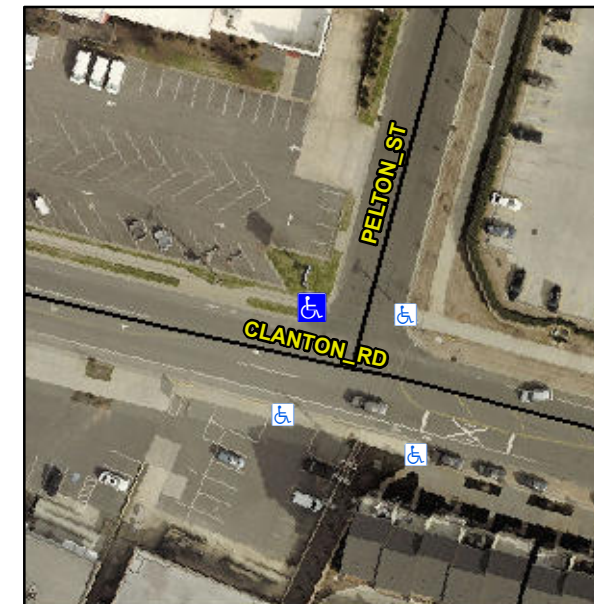
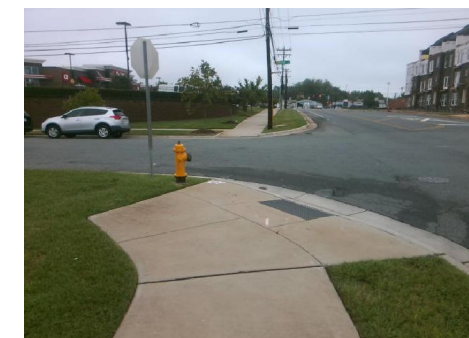
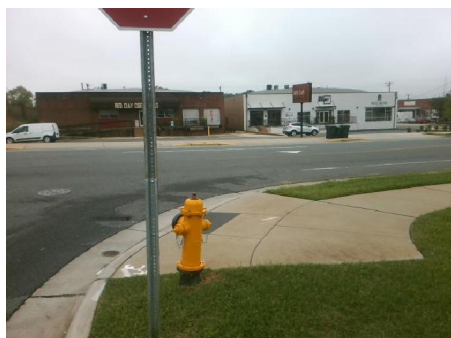
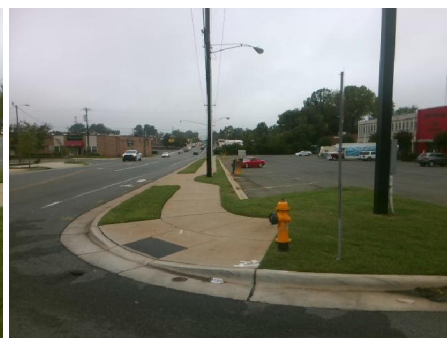
Not Found, R304.2.2

Compliance	Description	Data	Compliance	Description	Data
N/A	Ramp Length (in)	58.0	No	Ramp Slope (%)	8.6
Yes	Ramp Width (in)	49.0	Yes	Ramp XSlope (%)	1.6
N/A	Flare Type LT	N/A	N/A	Flare Type RT	N/A
N/A	Flare Slope LT (%)	N/A	N/A	Flare Slope RT (%)	N/A
N/A	Flare Traversable LT?	N/A	N/A	Flare Traversable RT?	N/A
N/A	Landing Length (in)	N/A	N/A	DWS Provided?	N/A
N/A	Landing Width (in)	N/A	N/A	DWS Contrast?	N/A
N/A	Landing Slope (%)	N/A	N/A	DWS Length (in)	N/A
N/A	Landing X Slope (%)	N/A	N/A	DWS Full Width?	N/A
N/A	Landing Curb? (Y/N)	N/A	N/A	DWS Offset (in)	N/A
N/A	Shared Landing?	N/A			
N/A	Gutter Ponding?	N/A	N/A	Gutter Slope (%)	N/A
N/A	Gutter Lip Ht (in)	N/A	N/A	Gutter X Slope (%)	N/A
N/A	Painted X Walk1?	No	N/A	Painted X Walk2?	No
	X Walk 1 Direction	To SW		X Walk 2 Direction	To E
N/A	X Walk 1 Width (in)	N/A	N/A	X Walk 2 Width (in)	N/A
	X Walk 1 Slope (%)	1.7		X Walk 2 Slope (%)	2.8
	X Walk 1 X Slope (%)	4.8		X Walk 2 X Slope (%)	4.0

N/A	Ramp inside XWalk1?	N/A	N/A	Ramp inside XWalk2?	N/A
	Road Slope (%)	1.0	N/A	Clear Space?	N/A
	Road X Slope (%)	7.4	N/A	Clear Space to XWalk (in)	N/A
N/A	Any Obstructions?	N/A	N/A	Storm Grate/Utility Hazard?	N/A
	Obstruction Type			Storm Grate/Utility Type	
		N/A			N/A
			Yes	Surface Condition? (G/P)	Good

Remove & Replace Curb Ramp With Two New Directional Ramps or Equivalent.

Total Cost: \$ 3200.00
