# Access Compliance Report

## Public Rights-of-Way

### (Curb Ramps)

| Intersection ID: 2421 | Main Street: CEDARDALE RIDGE CT | Cross Street: HIDDEN MEADOW LN | Location: | W |

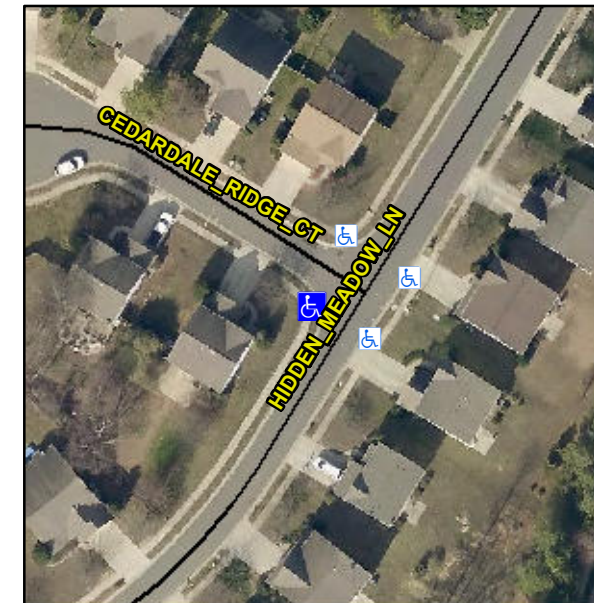
| ADA ID: A17528A07922 | Ramp Type: PerpDiag | Initial Pass/Fail: Fail | Overall Compliance: No | Severity Score: 25 |

**Not Found, R304.5.3**

| Compliance | Description | Data | Compliance | Description | Data |
|---|---|---|---|---|---|
| N/A | Ramp Length (in) | 51.0 | Yes | Ramp Slope (%) | 8.1 |
| Yes | Ramp Width (in) | 48.0 | No | Ramp XSlope (%) | 9.1 |

**Remove & Replace Curb Ramp With Two New Directional Ramps or Equivalent.**

Total Cost: \$ 3200.00
