# Access Compliance Report

## Public Rights-of-Way

### (Curb Ramps)

Intersection ID: 30476	Main Street: CREEK_TURN_DR	Cross Street: PLANTERS_ROW_DR	Location: SE
ADA ID: A17662F6C75F	Ramp Type: PerpDiag	Initial Pass/Fail: Fail	Overall Compliance: No
Severity Score: 21.25			
Codes/Mitigation Info/Possible Solution		Field Measurements/Component Compliance

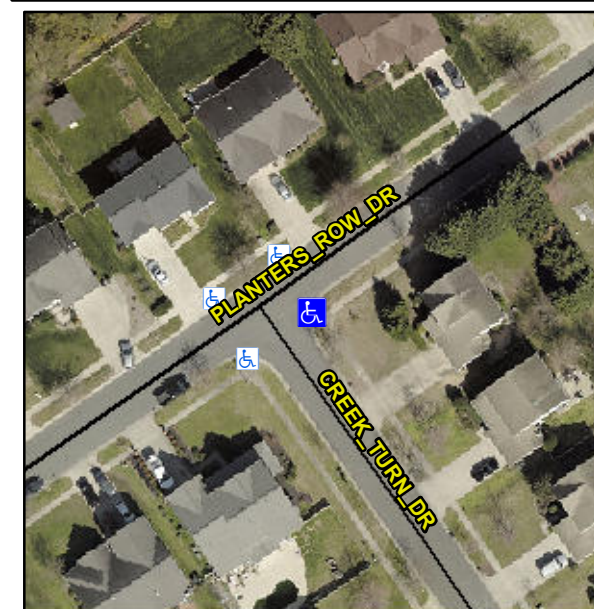
**Not Found, R304.5.1, R304.2.2**

Compliance	Description	Data	Compliance	Description	Data
N/A	Ramp Length (in)	85.0	No	Ramp Slope (%)	9.9
No	Ramp Width (in)	36.0	Yes	Ramp XSlope (%)	1.6
N/A	Flare Type LT	N/A	N/A	Flare Type RT	N/A
N/A	Flare Slope LT (%)	N/A	N/A	Flare Slope RT (%)	N/A
N/A	Flare Traversable LT?	N/A	N/A	Flare Traversable RT?	N/A
N/A	Landing Length (in)	N/A	N/A	DWS Provided?	N/A
N/A	Landing Width (in)	N/A	N/A	DWS Contrast?	N/A
N/A	Landing Slope (%)	N/A	N/A	DWS Length (in)	N/A
N/A	Landing X Slope (%)	N/A	N/A	DWS Full Width?	N/A
N/A	Landing Curb? (Y/N)	N/A	N/A	DWS Offset (in)	N/A
N/A	Shared Landing?	N/A			
N/A	Gutter Ponding?	N/A	N/A	Gutter Slope (%)	N/A
N/A	Gutter Lip Ht (in)	N/A	N/A	Gutter X Slope (%)	N/A
N/A	Painted X Walk1?	No	N/A	Painted X Walk2?	No
	X Walk 1 Direction	To NW		X Walk 2 Direction	To SW
N/A	X Walk 1 Width (in)	N/A	N/A	X Walk 2 Width (in)	N/A
	X Walk 1 Slope (%)	0.3		X Walk 2 Slope (%)	2.8
	X Walk 1 X Slope (%)	1.8		X Walk 2 X Slope (%)	2.2

N/A	Ramp inside XWalk1?	N/A	N/A	Ramp inside XWalk2?	N/A
	Road Slope (%)	1.4	N/A	Clear Space?	N/A
	Road X Slope (%)	0.5	N/A	Clear Space to XWalk (in)	N/A
N/A	Any Obstructions?	N/A	N/A	Storm Grate/Utility Hazard?	N/A
	Obstruction Type			Storm Grate/Utility Type	
		N/A			N/A
		Yes		Surface Condition? (G/P)	Good

**Remove & Replace Curb Ramp With Two New Directional Ramps or Equivalent.**
