Access Compliance Report Public Rights-of-Way (Curb Ramps)

Intersection ID: 4518	ntersection ID: 45183 Main Street: WESTON_GLEN_DR		Cross Street: COMMUNITY_HOUSE_RD					Location:	S
ADA ID: A1919B3157			Initial P	Initial Pass/Fail: Fail Overall Compliance: N			nce: N	o Severity Score:	21.25
Codes/Mitigation Info/Possible Solution				Field Measurements/Component Compliance					
Possible Solutions:									Data
KILLE	B. S. J.	Remove & Replace Curb Ramp With Two New Directional Ramps or Equivalent.	/:+h	N/A	Ramp Length (in)	71.0	Yes	Ramp Slope (%)	7.7
			/11/1	No	Ramp Width (in)	37.5	No	Ramp XSlope (%)	5.7
				N/A	Flare Type LT	57.5 N/A	N/A	Flare Type RT	0.7 N/A
				N/A	Flare Slope LT (%)	N/A	N/A	Flare Slope RT (%)	N/A
				N/A	Flare Traversable LT?	N/A		Flare Traversable RT?	N/A
				N/A	Landing Length (in)	N/A	N/A	DWS Provided?	N/A N/A
		Surveyor Notes:		N/A	Landing Width (in)	N/A		DWS Contrast?	N/A
		,		N/A	Landing Slope (%)	N/A		DWS Length (in)	N/A
		N/A		N/A	Landing X Slope (%)	N/A	N/A	DWS Full Width?	N/A

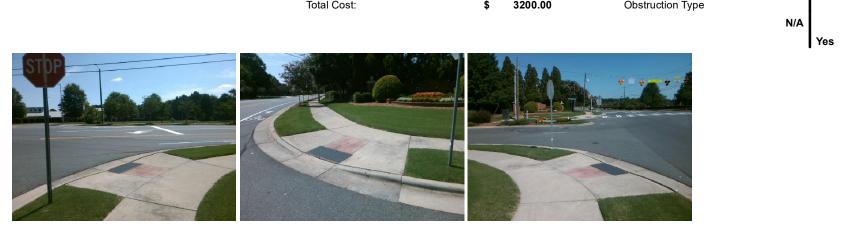
Store 1	111 Haire			N/A	Landing Curb? (Y/N)	N/A	N/A	DWS Offset (in)	N/A N/A
				N/A	Shared Landing?	N/A	N/A	DWS Oliset (III)	IN/A
11 11 11 11	2-12 4 1 1 1 1 1 1 1 1 1 1 1 1 1 1 1 1 1 1	PROW/ADA:		N/A	Gutter Ponding?	N/A	N/A	Gutter Slope (%)	N/A
					8		N/A	,	
1 11 0000	11111 and a	Not Found, R304.5.1, R304.5.3		N/A	Gutter Lip Ht (in)	1.0		Gutter X Slope (%)	N/A
	5 7982 111			N/A	Painted X Walk1?	No Ta NE	N/A	Painted X Walk2?	No Ta Nuv
<u>.</u>	La Malli				X Walk 1 Direction	To NE		X Walk 2 Direction	To NW
				N/A	X Walk 1 Width (in)	N/A	N/A	X Walk 2 Width (in)	N/A
Street 1 Name	COMMUNITY HOUSE RD				X Walk 1 Slope (%)	8.8		X Walk 2 Slope (%)	0.8
Stop Condition-Street 2	None				X Walk 1 X Slope (%)	0.6		X Walk 2 X Slope (%)	6.1
Street 2 Name	WESTON GLEN DR			N/A	Ramp inside XWalk1?	N/A	N/A	Ramp inside XWalk2?	N/A
Stop Condition-Street 1	StopSign				Road Slope (%)	3.6	N/A	Clear Space?	N/A
					Road X Slope (%)	5.3	N/A	Clear Space to XWalk (in)	N/A

N/A	Any Obstructions?	N/A	N/A	Storm Grate/Utility Hazard?	N/A
		Total Cost: \$ 32	200.00		Obstruction Type			Storm Grate/Utility Type	
						N/A			N/A
