## **Access Compliance Report Public Rights-of-Way** (Curb Ramps)

Intersection ID: 10036927 Main Street: S SHARON AMITY RD **Cross Street: N/A** Location: NE ADA ID: A1951D6E46C2 Ramp Type: PerpDiag Initial Pass/Fail: Fail **Overall Compliance: No Severity Score:** 25

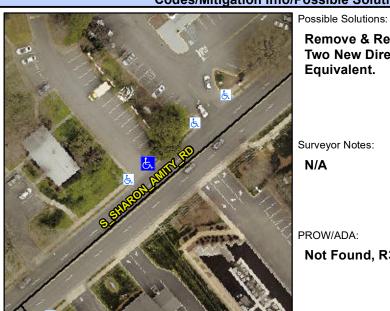
Field Measurements/Component Compliance						
Compliance Description		Data	Comp	liance Description	Data	
N/A	Ramp Length (in)	68.0	Yes	Ramp Slope (%)	7.6	
Yes	Ramp Width (in)	48.0	No	Ramp XSlope (%)	7.9	
N/A	Flare Type LT	N/A	N/A	Flare Type RT	N/A	
N/A	Flare Slope LT (%)	N/A	N/A	Flare Slope RT (%)	N/A	
N/A	Flare Traversable LT?	N/A	N/A	Flare Traversable RT?	N/A	
N/A	Landing Length (in)	N/A	N/A	DWS Provided?	N/A	
N/A	Landing Width (in)	N/A	N/A	DWS Contrast?	N/A	
N/A	Landing Slope (%)	N/A	N/A	DWS Length (in)	N/A	
N/A	Landing X Slope (%)	N/A	N/A	DWS Full Width?	N/A	
N/A	Landing Curb? (Y/N)	N/A	N/A	DWS Offset (in)	N/A	
N/A	Shared Landing?	N/A				
N/A	Gutter Ponding?	N/A	N/A	Gutter Slope (%)	N/A	
N/A	Gutter Lip Ht (in)	N/A	N/A	Gutter X Slope (%)	N/A	
N/A	Painted X Walk1?	No	N/A	Painted X Walk2?	No	
	X Walk 1 Direction	To SW		X Walk 2 Direction	To SE	
N/A	X Walk 1 Width (in)	N/A	N/A	X Walk 2 Width (in)	N/A	
	X Walk 1 Slope (%)	3.3		X Walk 2 Slope (%)	6.5

X Walk 1 X Slope (%)	7.1		X Walk 2 X Slope (%)	2.9	
N/A	Ramp inside XWalk1?	N/A	N/A	Ramp inside XWalk2?	N/A	
	Road Slope (%)	9.8	N/A	Clear Space?	N/A	
	Road X Slope (%)	2.3	N/A	Clear Space to XWalk (in)	N/A	
N/A	Any Obstructions?	N/A	N/A	Storm Grate/Utility Hazard?	N/A	
	Obstruction Type			Storm Grate/Utility Type		
		N/A			N/A	
			Yes	Surface Condition? (G/P)	Good

Street 1 Name Stop Condition-Street 2 Street 2 Name Stop Condition-Street 1 Remove & Replace Curb Ramp With **Two New Directional Ramps or** Equivalent.

Total Cost: 3200.00
