Intersection ID: 11357	Main Street: W_TRADE_ST	Cross Street: N_IRWIN_AV	Location:	N
ADA ID: A198E522B97C	Ramp Type: Perp	Initial Pass/Fail: Fail	Overall Compliance: No	Severity Score: 13.75

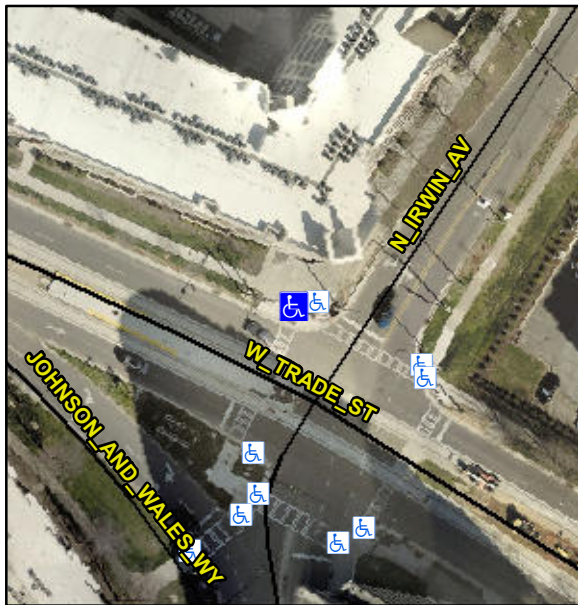
Compliance	Description	Data	Compliance	Description	Data
N/A	Ramp Length (in)	74.0	No	Ramp Slope (%)	9.7
Yes	Ramp Width (in)	58.0	Yes	Ramp XSlope (%)	3.6
N/A	Flare Type LT	N/A	N/A	Flare Type RT	N/A
N/A	Flare Slope LT (%)	N/A	N/A	Flare Slope RT (%)	N/A
N/A	Flare Traversable LT?	N/A	N/A	Flare Traversable RT?	N/A
N/A	Landing Length (in)	N/A	N/A	DWS Provided?	N/A
N/A	Landing Width (in)	N/A	N/A	DWS Contrast?	N/A
N/A	Landing Slope (%)	N/A	N/A	DWS Length (in)	N/A
N/A	Landing X Slope (%)	N/A	N/A	DWS Full Width?	N/A
N/A	Landing Curb? (Y/N)	N/A	N/A	DWS Offset (in)	N/A
N/A	Shared Landing?	N/A			
N/A	Gutter Ponding?	N/A	N/A	Gutter Slope (%)	N/A
N/A	Gutter Lip Ht (in)	N/A	N/A	Gutter X Slope (%)	N/A
N/A	Painted X Walk1?	Yes	N/A	Painted X Walk2?	N/A
	X Walk 1 Direction	To SW		X Walk 2 Direction	N/A
N/A	X Walk 1 Width (in)	83.0	N/A	X Walk 2 Width (in)	N/A
	X Walk 1 Slope (%)	1.6		X Walk 2 Slope (%)	N/A
	X Walk 1 X Slope (%)	4.7		X Walk 2 X Slope (%)	N/A

N/A	Ramp inside XWalk1?	Yes	N/A	Ramp inside XWalk2?	N/A
	Road Slope (%)	N/A	N/A	Clear Space?	N/A
	Road X Slope (%)	N/A	N/A	Clear Space to XWalk (in)	N/A
N/A	Any Obstructions?	N/A	N/A	Storm Grate/Utility Hazard?	N/A
	Obstruction Type			Storm Grate/Utility Type	
		N/A			N/A
			Yes	Surface Condition? (G/P)	Good

Possible Solutions:

Remove & Replace Entire Ramp.

R304.2.2
