# Access Compliance Report

## Public Rights-of-Way

Intersection ID: 13514	Main Street: WINGATE_AV	Cross Street: OCRACOCKE_ST	Location:	N
ADA ID: A1A19140476C	Ramp Type: BlendTrans2	Initial Pass/Fail: Fail	Overall Compliance: No	Severity Score: 10

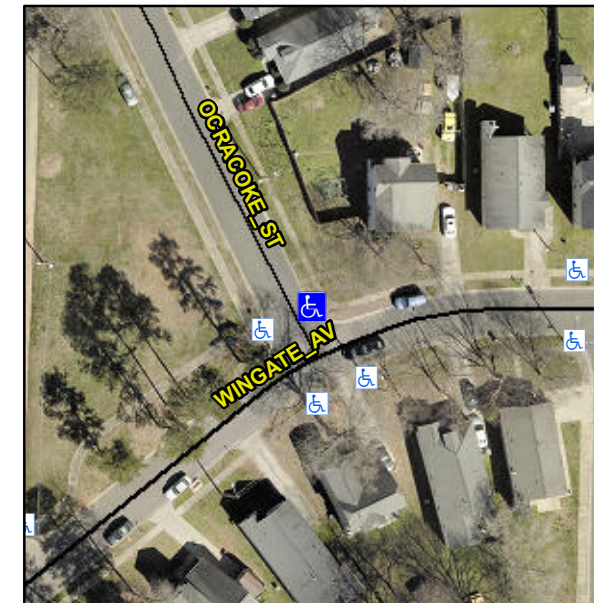
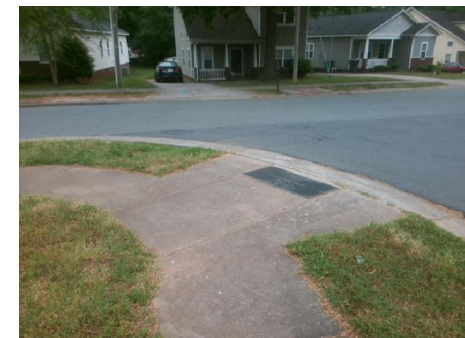
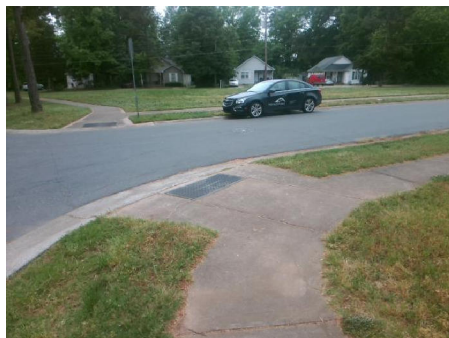
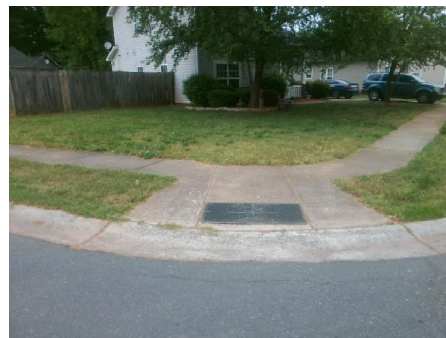
**Not Found, R304.5.1, R304.5.3**

Compliance	Description	Data	Compliance	Description	Data
N/A	Ramp Length (in)	108.0	Yes	BlendTrans Slope (%)	2.3
No	Ramp Width (in)	45.5	No	BlendTrans XSlope (%)	2.5
N/A	Flare Type LT	N/A	N/A	Flare Type RT	N/A
N/A	Flare Slope LT (%)	N/A	N/A	Flare Slope RT (%)	N/A
N/A	Flare Traversable LT?	N/A	N/A	Flare Traversable RT?	N/A
N/A	Landing Length (in)	N/A	N/A	DWS Provided?	N/A
N/A	Landing Width (in)	N/A	N/A	DWS Contrast?	N/A
N/A	Landing Slope (%)	N/A	N/A	DWS Length (in)	N/A
N/A	Landing X Slope (%)	N/A	N/A	DWS Full Width?	N/A
N/A	Landing Curb? (Y/N)	N/A	N/A	DWS Offset (in)	N/A
N/A	Shared Landing?	N/A			
N/A	Gutter Ponding?	N/A	N/A	Gutter Slope (%)	N/A
N/A	Gutter Lip Ht (in)	N/A	N/A	Gutter X Slope (%)	N/A
N/A	Painted X Walk1?	No	N/A	Painted X Walk2?	No
	X Walk 1 Direction	To SE		X Walk 2 Direction	To SW
	X Walk 1 Width (in)	N/A		X Walk 2 Width (in)	N/A
	X Walk 1 Slope (%)	1.2		X Walk 2 Slope (%)	0.9
	X Walk 1 X Slope (%)	1.4		X Walk 2 X Slope (%)	1.5

N/A	Ramp inside XWalk1?	N/A	N/A	Ramp inside XWalk2?	N/A
	Road Slope (%)	0.7		Clear Space?	N/A
	Road X Slope (%)	4.7	N/A	Clear Space to XWalk (in)	N/A
N/A	Any Obstructions?	N/A	N/A	Storm Grate/Utility Hazard?	N/A
	Obstruction Type			Storm Grate/Utility Type	
		N/A			N/A
			Yes	Surface Condition? (G/P)	Good
			No	Curb Slope (%)	13.1

**Remove & Replace Curb Ramp With Two New Directional Ramps or Equivalent.**
