Access Compliance Report

Public Rights-of-Way

(Curb Ramps)

Intersection ID: 31199	Main Street: PROSPERITY_CHURCH_RD	Cross Street: TRADITION_RD	Location: NE
ADA ID: A1A45355C6EE	Ramp Type: Combination2	Initial Pass/Fail: Fail	Overall Compliance: No
			Severity Score: 46.25

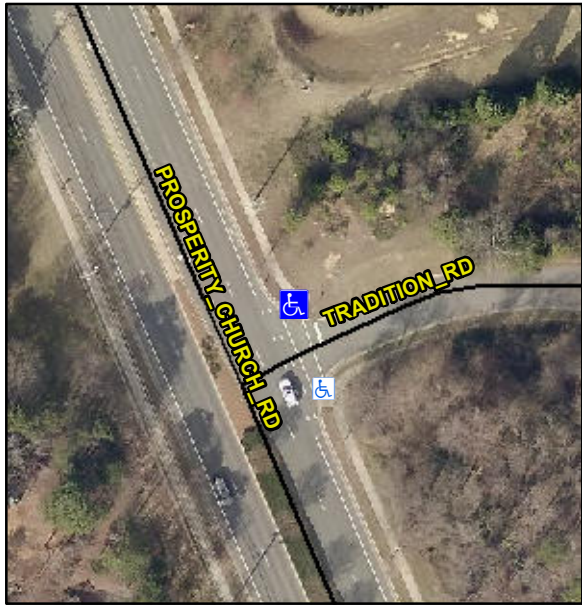
Possible Solutions:			Compliance	Description	Data	Compliance	Description	Data
	Remove & Replace Entire Ramp.			N/A	Ramp Length LT (in)	47.0	N/A	Ramp Length RT (in)	N/A
				Yes	Ramp Width LT (in)	59.0	N/A	Ramp Width RT (in)	N/A
				No	Ramp Slope LT (%)	11.5	N/A	Ramp Slope RT (%)	N/A
				No	Ramp XSlope LT (%)	2.1	N/A	Ramp XSlope RT (%)	N/A
				N/A	Ramp Length (in)	72.0	No	Ramp Slope (%)	12.1
				No	Ramp Width (in)	36.0	No	Ramp XSlope (%)	5.8
	Surveyor Notes:			N/A	Flare Type LT	N/A	N/A	Flare Type RT	N/A
	N/A			N/A	Flare Slope LT (%)	N/A	N/A	Flare Slope RT (%)	N/A
				N/A	Flare Traversable LT?	N/A	N/A	Flare Traversable RT?	N/A
PROW/ADA:			N/A	Landing Length (in)	N/A	N/A	DWS Provided?	N/A	
R304.5.1, R304.2.2, R304.5.3,			N/A	Landing Width (in)	N/A	N/A	DWS Contrast?	N/A	
R304.3.2			N/A	Landing Slope (%)	N/A	N/A	DWS Length (in)	N/A

N/A	Landing X Slope (%)	N/A	N/A	DWS Full Width?	N/A	
			N/A	Landing Curb? (Y/N)	N/A	N/A	DWS Offset (in)	N/A	
			N/A	Shared Landing?	N/A				
			N/A	Gutter Ponding?	N/A	N/A	Gutter Slope (%)	N/A	
			N/A	Gutter Lip Ht (in)	N/A	N/A	Gutter X Slope (%)	N/A	
			N/A	Painted X Walk1?	Yes	N/A	Painted X Walk2?	N/A	
				X Walk 1 Direction	To SE		X Walk 2 Direction	N/A	
				X Walk 1 Width (in)	104.0		X Walk 2 Width (in)	N/A	
				X Walk 1 Slope (%)	2.0		X Walk 2 Slope (%)	N/A	
				X Walk 1 X Slope (%)	9.2		X Walk 2 X Slope (%)	N/A	
Total Cost:			N/A	Ramp inside XWalk1?	Yes	N/A	Ramp inside XWalk2?	N/A	
				Road Slope (%)	N/A		Clear Space?	N/A	
				Road X Slope (%)	N/A	N/A	Clear Space to XWalk (in)	N/A	
						N/A	Any Obstruction?	N/A	
							Obstruction Type	N/A	
						N/A	Storm Grate/Utility Hazard?	N/A	
							Storm Grate/Utility Type	N/A	
						Yes	Surface Condition? (G/P)	Good	
							Curb Slope (%)	N/A
