Access Compliance Report

Public Rights-of-Way

(Curb Ramps)

Intersection ID: 42580	Main Street: GERALDINE_POWE_DR	Cross Street: RISING_OAK_DR	Location: NW
ADA ID: A1ABCA2C4075	Ramp Type: PerpDiag	Initial Pass/Fail: Fail	Overall Compliance: No
		Severity Score: 10

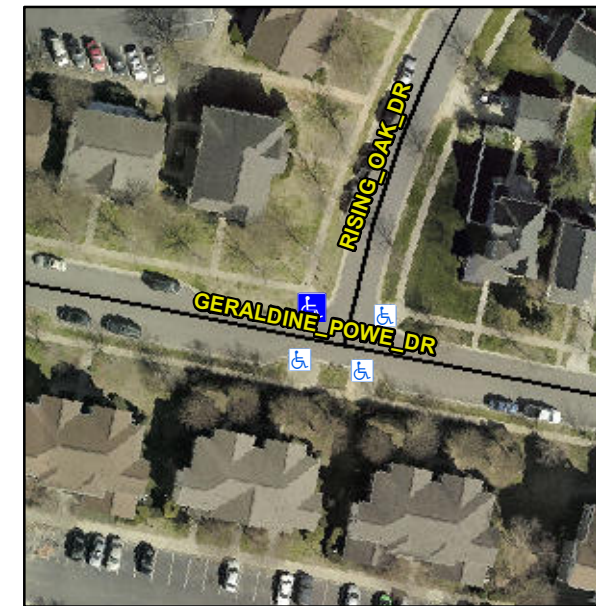
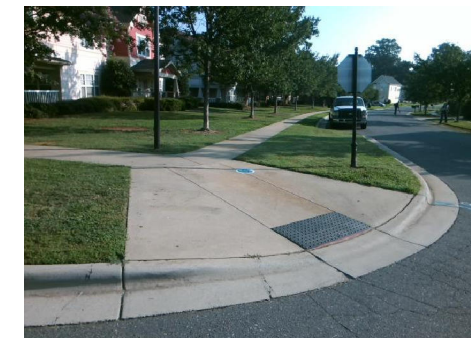
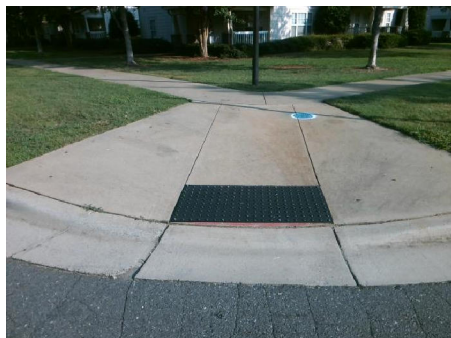
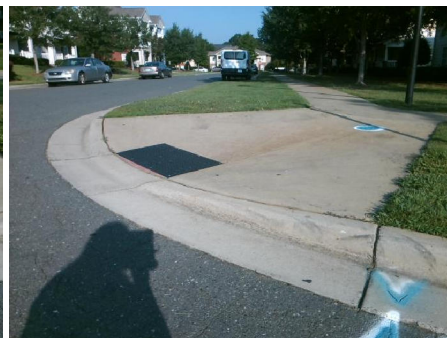
Not Found, R304.5.1, R304.5.3

Compliance	Description	Data	Compliance	Description	Data
N/A	Ramp Length (in)	146.0	Yes	Ramp Slope (%)	5.7
No	Ramp Width (in)	47.0	No	Ramp XSlope (%)	4.0
N/A	Flare Type LT	N/A	N/A	Flare Type RT	N/A
N/A	Flare Slope LT (%)	N/A	N/A	Flare Slope RT (%)	N/A
N/A	Flare Traversable LT?	N/A	N/A	Flare Traversable RT?	N/A
N/A	Landing Length (in)	N/A	N/A	DWS Provided?	N/A
N/A	Landing Width (in)	N/A	N/A	DWS Contrast?	N/A
N/A	Landing Slope (%)	N/A	N/A	DWS Length (in)	N/A
N/A	Landing X Slope (%)	N/A	N/A	DWS Full Width?	N/A
N/A	Landing Curb? (Y/N)	N/A	N/A	DWS Offset (in)	N/A
N/A	Shared Landing?	N/A			
N/A	Gutter Ponding?	N/A	N/A	Gutter Slope (%)	N/A
N/A	Gutter Lip Ht (in)	N/A	N/A	Gutter X Slope (%)	N/A
N/A	Painted X Walk1?	No	N/A	Painted X Walk2?	No
	X Walk 1 Direction	To S		X Walk 2 Direction	To SE
N/A	X Walk 1 Width (in)	N/A	N/A	X Walk 2 Width (in)	N/A
	X Walk 1 Slope (%)	2.8		X Walk 2 Slope (%)	0.6
	X Walk 1 X Slope (%)	0.7		X Walk 2 X Slope (%)	3.4

N/A	Ramp inside XWalk1?	N/A	N/A	Ramp inside XWalk2?	N/A
	Road Slope (%)	0.9	N/A	Clear Space?	N/A
	Road X Slope (%)	3.6	N/A	Clear Space to XWalk (in)	N/A
N/A	Any Obstructions?	N/A	N/A	Storm Grate/Utility Hazard?	N/A
	Obstruction Type			Storm Grate/Utility Type	
		N/A			N/A
			Yes	Surface Condition? (G/P)	Good

Remove & Replace Curb Ramp With Two New Directional Ramps or Equivalent.
