Access Compliance Report Public Rights-of-Way (Curb Ramps)

Intersection ID: 43676 Main Street: SARDIS COMMONS LN **Cross Street: SARDIS RD** Location: SE ADA ID: A1CC0E6B7BFB Ramp Type: PerpDiag Initial Pass/Fail: Fail **Overall Compliance: No Severity Score:** 10

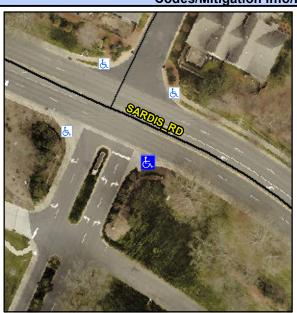
Fleid Measurements/Component Compliance						
	Comp	Compliance Description		Compliance Description		Data
	N/A	Ramp Length (in)	63.0	Yes	Ramp Slope (%)	6.9
	No	Ramp Width (in)	45.5	No	Ramp XSlope (%)	3.0
	N/A	Flare Type LT	N/A	N/A	Flare Type RT	N/A
	N/A	Flare Slope LT (%)	N/A	N/A	Flare Slope RT (%)	N/A
	N/A	Flare Traversable LT?	N/A	N/A	Flare Traversable RT?	N/A
	N/A	Landing Length (in)	N/A	N/A	DWS Provided?	N/A
	N/A	Landing Width (in)	N/A	N/A	DWS Contrast?	N/A
	N/A	Landing Slope (%)	N/A	N/A	DWS Length (in)	N/A
	N/A	Landing X Slope (%)	N/A	N/A	DWS Full Width?	N/A
	N/A	Landing Curb? (Y/N)	N/A	N/A	DWS Offset (in)	N/A
	N/A	Shared Landing?	N/A			
	N/A	Gutter Ponding?	N/A	N/A	Gutter Slope (%)	N/A
	N/A	Gutter Lip Ht (in)	N/A	N/A	Gutter X Slope (%)	N/A
	N/A	Painted X Walk1?	No	N/A	Painted X Walk2?	No
		X Walk 1 Direction	To NE		X Walk 2 Direction	To NW
	N/A	X Walk 1 Width (in)	N/A	N/A	X Walk 2 Width (in)	N/A
		X Walk 1 Slope (%)	5.5		X Walk 2 Slope (%)	9.1

X Walk 1 X Slope (%)	8.4		X Walk 2 X Slope (%)	3.0
	N/A	Ramp inside XWalk1?	N/A	N/A	Ramp inside XWalk2?	N/A
		Road Slope (%)	3.6	N/A	Clear Space?	N/A
		Road X Slope (%)	10.5	N/A	Clear Space to XWalk (in)	N/A
	N/A	Any Obstructions?	N/A	N/A	Storm Grate/Utility Hazard?	N/A
		Obstruction Type			Storm Grate/Utility Type	
			N/A			N/A
				Yes	Surface Condition? (G/P)	Good

Possible Solutions: Remove & Replace Curb Ramp With Two New Directional Ramps or Equivalent. Surveyor Notes: N/A Not Found, R304.5.1, R304.5.3
