Access Compliance Report

Public Rights-of-Way

(Curb Ramps)

Intersection ID: 10644	Main Street: FRAZIER_AV	Cross Street: MARTIN_ST	Location: W
ADA ID: A1DBB49B29A6	Ramp Type: Perp	Initial Pass/Fail: Fail	Overall Compliance: No
			Severity Score: 46.25

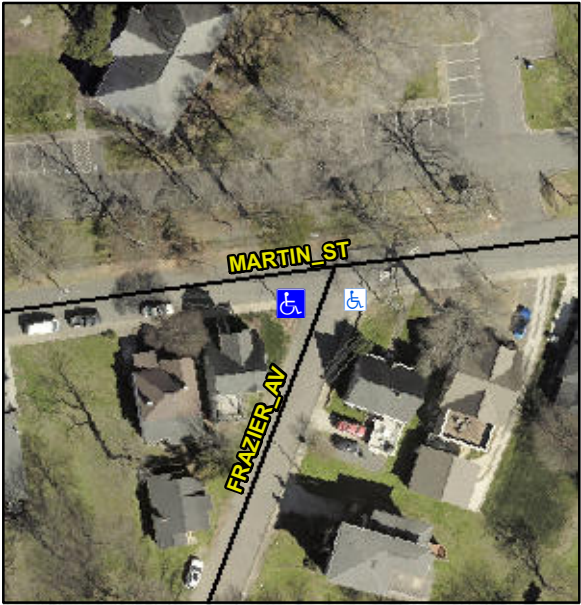
Possible Solutions:		Compliance	Description	Data
	Remove & Replace Entire Ramp.		No	Ramp Length (in)	48.0
			No	Ramp Width (in)	41.0
			N/A	Flare Type LT	N/A
			N/A	Flare Slope LT (%)	N/A
			N/A	Flare Traversable LT?	N/A
			N/A	Landing Length (in)	N/A
			N/A	Landing Width (in)	N/A
			N/A	Landing Slope (%)	N/A
			N/A	Landing X Slope (%)	N/A
<p>Surveyor Notes:</p> <p>N/A</p> <p>PROW/ADA:</p> <p>Not Found, R304.5.1, R304.2.2, R304.5.3</p>			N/A	Flare Type RT	N/A
			N/A	Flare Slope RT (%)	N/A
			N/A	Flare Traversable RT?	N/A
			N/A	DWS Provided?	N/A
			N/A	DWS Contrast?	N/A
			N/A	DWS Length (in)	N/A
			N/A	DWS Full Width?	N/A
			N/A	DWS Offset (in)	N/A
			N/A	Gutter Ponding?	N/A
			N/A	Gutter Lip Ht (in)	0.5
			No	Painted X Walk1?	N/A
				X Walk 1 Direction	To E
			N/A	X Walk 1 Width (in)	N/A
				X Walk 1 Slope (%)	1.5
				X Walk 1 X Slope (%)	8.2

N/A	Ramp inside XWalk1?	N/A
			N/A	Road Slope (%)	N/A
			N/A	Road X Slope (%)	N/A
			N/A	Any Obstructions?	N/A
				Obstruction Type	
Total Cost:		\$ 1850.00			
			N/A	Clear Space?	N/A
			N/A	Clear Space to XWalk (in)	N/A
			N/A	Storm Grate/Utility Hazard?	N/A
				Storm Grate/Utility Type	
			N/A		N/A
			Yes	Surface Condition? (G/P)	Good
