Access Compliance Report Public Rights-of-Way (Curb Ramps)

Intersection ID: 10034789Main Street: POTOMAC_RIVER_PYCross Street: N/ALocation: WADA ID: A1F52EA16398Ramp Type: PerpInitial Pass/Fail: FailOverall Compliance: NoSeverity Score: 12.5

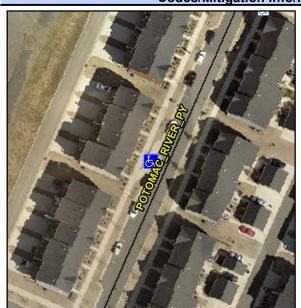
Field Measurements/Component Compliance							
Comp	liance Description	Data	Comp	liance Description	Data		
N/A	Ramp Length (in)	78.0	No	Ramp Slope (%)	8.6		
Yes	Ramp Width (in)	56.0	Yes	Ramp XSlope (%)	0.3		
N/A	Flare Type LT	N/A	N/A	Flare Type RT	N/A		
N/A	Flare Slope LT (%)	N/A	N/A	Flare Slope RT (%)	N/A		
N/A	Flare Traversable LT?	No	N/A	Flare Traversable RT?	No		
N/A	Landing Length (in)	N/A	N/A	DWS Provided?	N/A		
N/A	Landing Width (in)	N/A	N/A	DWS Contrast?	N/A		
N/A	Landing Slope (%)	N/A	N/A	DWS Length (in)	N/A		
N/A	Landing X Slope (%)	N/A	N/A	DWS Full Width?	N/A		
N/A	Landing Curb? (Y/N)	N/A	N/A	DWS Offset (in)	N/A		
N/A	Shared Landing?	N/A					
N/A	Gutter Ponding?	N/A	N/A	Gutter Slope (%)	N/A		
N/A	Gutter Lip Ht (in)	N/A	N/A	Gutter X Slope (%)	N/A		
N/A	Painted X Walk1?	No	N/A	Painted X Walk2?	N/A		
	X Walk 1 Direction	To E		X Walk 2 Direction	N/A		
N/A	X Walk 1 Width (in)	N/A	N/A	X Walk 2 Width (in)	N/A

X Walk 1 Slope (%)	0.9		X Walk 2 Slope (%)	N/A		
	X Walk 1 X Slope (%)	2.3		X Walk 2 X Slope (%)	N/A		
N/A	Ramp inside XWalk1?	N/A	N/A	Ramp inside XWalk2?	N/A		
	Road Slope (%)	N/A	N/A	Clear Space?	N/A		
	Road X Slope (%)	N/A	N/A	Clear Space to XWalk (in)	N/A		
N/A	Any Obstructions?	N/A	N/A	Storm Grate/Utility Hazard?	N/A		
	Obstruction Type			Storm Grate/Utility Type			
		N/A			N/A		
			Yes	Surface Condition? (G/P)	Good

Possible Solutions:	
Remove & Replace Entire Ramp.	ı
	•
	1
	ı
	ı
	ı
Surveyor Notes:	ı
N/A	ı
PROW/ADA:	
Not Found, R304.2.2	'
	,
