Access Compliance Report

Public Rights-of-Way

(Curb Ramps)

Intersection ID: 10867	Main Street: E_35TH_ST	Cross Street: THE_PLAZA	Location: E
ADA ID: A2087C37B2AD	Ramp Type: PerpDiag	Initial Pass/Fail: Fail	Overall Compliance: No
			Severity Score: 21.25

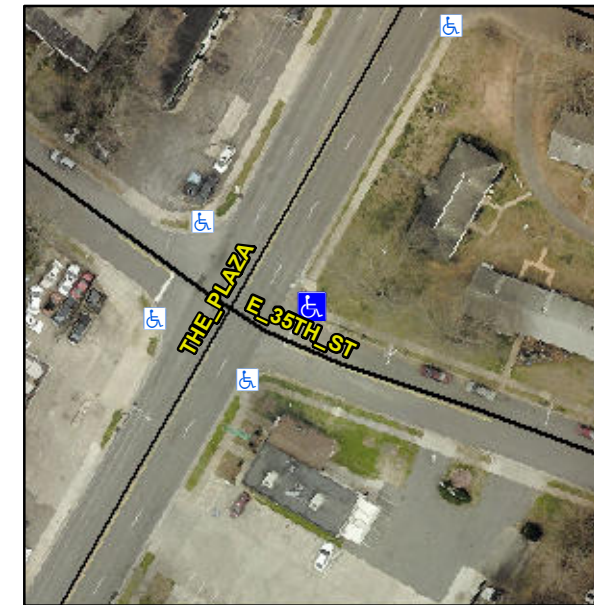
Not Found, R304.5.1, R304.2.2

Compliance	Description	Data	Compliance	Description	Data
N/A	Ramp Length (in)	65.0	No	Ramp Slope (%)	8.6
No	Ramp Width (in)	47.5	Yes	Ramp XSlope (%)	1.2
N/A	Flare Type LT	N/A	N/A	Flare Type RT	N/A
N/A	Flare Slope LT (%)	N/A	N/A	Flare Slope RT (%)	N/A
N/A	Flare Traversable LT?	N/A	N/A	Flare Traversable RT?	N/A
N/A	Landing Length (in)	N/A	N/A	DWS Provided?	N/A
N/A	Landing Width (in)	N/A	N/A	DWS Contrast?	N/A
N/A	Landing Slope (%)	N/A	N/A	DWS Length (in)	N/A
N/A	Landing X Slope (%)	N/A	N/A	DWS Full Width?	N/A
N/A	Landing Curb? (Y/N)	N/A	N/A	DWS Offset (in)	N/A
N/A	Shared Landing?	N/A			
N/A	Gutter Ponding?	N/A	N/A	Gutter Slope (%)	N/A
N/A	Gutter Lip Ht (in)	N/A	N/A	Gutter X Slope (%)	N/A
N/A	Painted X Walk1?	No	N/A	Painted X Walk2?	No
	X Walk 1 Direction	To NW		X Walk 2 Direction	To SW
N/A	X Walk 1 Width (in)	N/A	N/A	X Walk 2 Width (in)	N/A
	X Walk 1 Slope (%)	4.9		X Walk 2 Slope (%)	0.0
	X Walk 1 X Slope (%)	1.0		X Walk 2 X Slope (%)	0.0

N/A	Ramp inside XWalk1?	N/A	N/A	Ramp inside XWalk2?	N/A
	Road Slope (%)	4.9	N/A	Clear Space?	N/A
	Road X Slope (%)	1.9	N/A	Clear Space to XWalk (in)	N/A
N/A	Any Obstructions?	N/A	N/A	Storm Grate/Utility Hazard?	N/A
	Obstruction Type			Storm Grate/Utility Type	
		N/A			N/A
			Yes	Surface Condition? (G/P)	Good

Remove & Replace Curb Ramp With Two New Directional Ramps or Equivalent.

Total Cost: \$ 3200.00
