Access Compliance Report

Public Rights-of-Way

(Curb Ramps)

| Intersection ID: 19402 | Main Street: GRETNA_GREEN_DR | Cross Street: S_TRYON_ST | Location: SW |

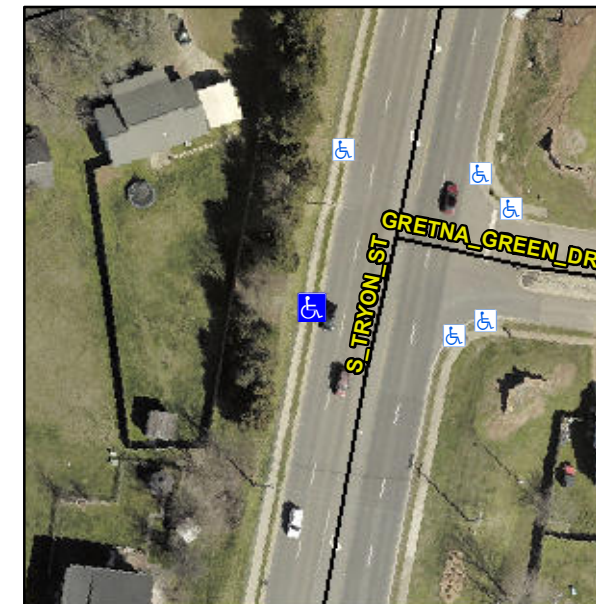
| ADA ID: A20CA0EBD765 | Ramp Type: Perp | Initial Pass/Fail: Pass | Overall Compliance: No |
| Severity Score: 20 | | | |

| Compliance | Description | Data | Compliance | Description | Data |
|---|---|---|---|---|---|
| No | Landing Length (in) | N/A | No | DWS Provided? | No |
| No | Landing Width (in) | N/A | N/A | DWS Contrast? | No |
| No | Landing Slope (%) | N/A | N/A | DWS Length (in) | N/A |
| No | Landing X Slope (%) | N/A | N/A | DWS Full Width? | No |

Possible Solutions:

Remove & Replace Entire Ramp.

R304.2.1, R304.2.2-Perp, R304.3.2-Para, R304.5.3, R305

Total Cost: \$ 1850.00

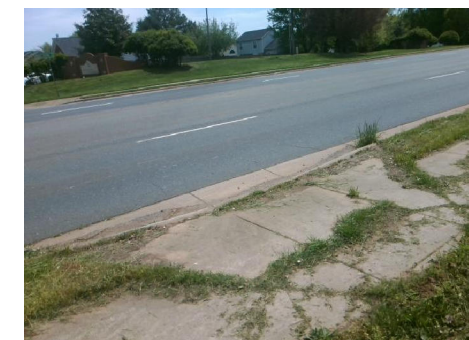
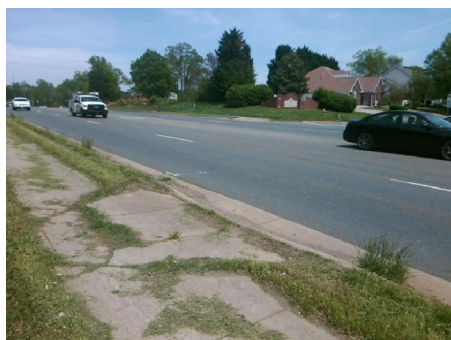
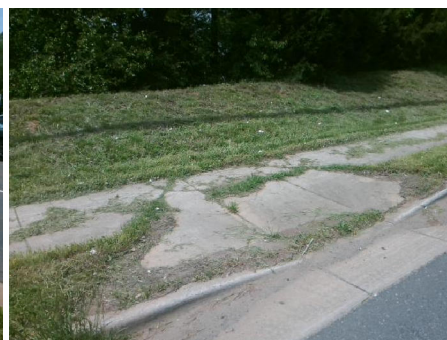
| Compliance | Description | Data | Compliance | Description | Data |
|---|---|---|---|---|---|
| N/A | Ramp Length (in) | 89.0 | Yes | Ramp Slope (%) | 7.5 |
| Yes | Ramp Width (in) | 48.0 | Yes | Ramp XSlope (%) | 1.2 |
| | | | Yes | Surface Condition? (G/P) | Good |
