# Access Compliance Report

## Public Rights-of-Way

### (Curb Ramps)

Intersection ID: 3147	Main Street: BROWNESTONE_VIEW_DR	Cross Street: MINERAL_RIDGE_WY	Location: W
ADA ID: A21B03D4A1A7	Ramp Type: Perp	Initial Pass/Fail: Fail	Overall Compliance: No
Severity Score: 18.75			
Codes/Mitigation Info/Possible Solution		Field Measurements/Component Compliance

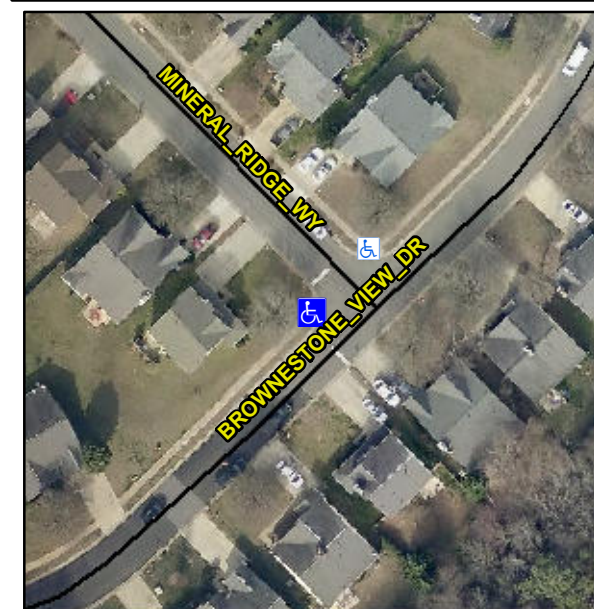
**Not Found, R304.5.1, R304.5.3**

Compliance	Description	Data	Compliance	Description	Data
N/A	Ramp Length (in)	96.0	Yes	Ramp Slope (%)	5.4
No	Ramp Width (in)	33.5	No	Ramp XSlope (%)	3.4
N/A	Flare Type LT	N/A	N/A	Flare Type RT	N/A
N/A	Flare Slope LT (%)	N/A	N/A	Flare Slope RT (%)	N/A
N/A	Flare Traversable LT?	N/A	N/A	Flare Traversable RT?	N/A
N/A	Landing Length (in)	N/A	N/A	DWS Provided?	N/A
N/A	Landing Width (in)	N/A	N/A	DWS Contrast?	N/A
N/A	Landing Slope (%)	N/A	N/A	DWS Length (in)	N/A
N/A	Landing X Slope (%)	N/A	N/A	DWS Full Width?	N/A
N/A	Landing Curb? (Y/N)	N/A	N/A	DWS Offset (in)	N/A
N/A	Shared Landing?	N/A			
N/A	Gutter Ponding?	N/A	N/A	Gutter Slope (%)	N/A
N/A	Gutter Lip Ht (in)	N/A	N/A	Gutter X Slope (%)	N/A
N/A	Painted X Walk1?	No	N/A	Painted X Walk2?	N/A
	X Walk 1 Direction	To NE		X Walk 2 Direction	N/A
N/A	X Walk 1 Width (in)	N/A	N/A	X Walk 2 Width (in)	N/A
	X Walk 1 Slope (%)	1.6		X Walk 2 Slope (%)	N/A
	X Walk 1 X Slope (%)	6.0		X Walk 2 X Slope (%)	N/A

N/A	Ramp inside XWalk1?	N/A	N/A	Ramp inside XWalk2?	N/A
	Road Slope (%)	N/A	N/A	Clear Space?	N/A
	Road X Slope (%)	N/A	N/A	Clear Space to XWalk (in)	N/A
N/A	Any Obstructions?	N/A	N/A	Storm Grate/Utility Hazard?	N/A
	Obstruction Type			Storm Grate/Utility Type	
		N/A			N/A
			Yes	Surface Condition? (G/P)	Good

**Remove & Replace Entire Ramp.**

Total Cost: \$ 1850.00
