# Access Compliance Report

## Public Rights-of-Way

### (Curb Ramps)

| Intersection ID: 44000 | | Main Street: ELROSE_PL | | Cross Street: GANDER_DR | | Location: NE | | | |

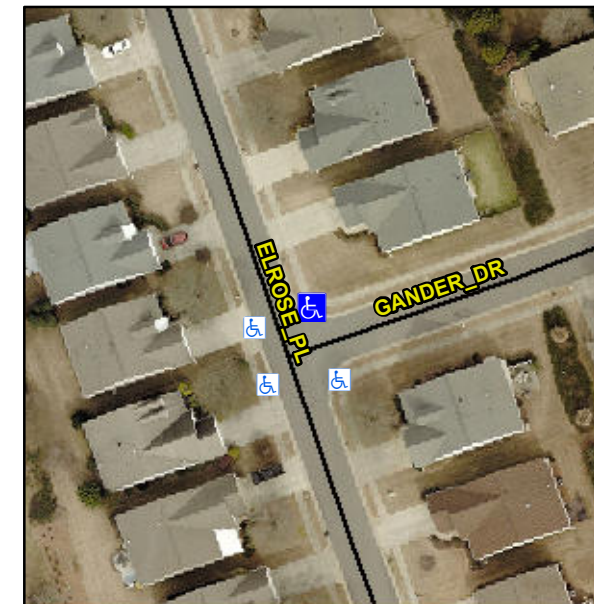
| ADA ID: A21EC8D686E3 | | Ramp Type: PerpDiag | | Initial Pass/Fail: Fail | | Overall Compliance: No | | Severity Score: 25 | |

**Not Found, R304.2.2, R304.5.3**

| Compliance | Description | Data | Compliance | Description | Data |
|---|---|---|---|---|---|
| N/A | Ramp Length (in) | 48.0 | No | Ramp Slope (%) | 8.7 |
| Yes | Ramp Width (in) | 48.0 | No | Ramp XSlope (%) | 6.1 |

**Remove & Replace Curb Ramp With Two New Directional Ramps or Equivalent.**
