Access Compliance Report

Public Rights-of-Way

(Curb Ramps)

Intersection ID: 45981	Main Street: LAUREL_VALLEY_RD	Cross Street: MASON_MILL_PL	Location: SW
ADA ID: A222DE040C96	Ramp Type: PerpDiag	Initial Pass/Fail: Fail	Overall Compliance: No
Severity Score: 22.5			
Codes/Mitigation Info/Possible Solution		Field Measurements/Component Compliance

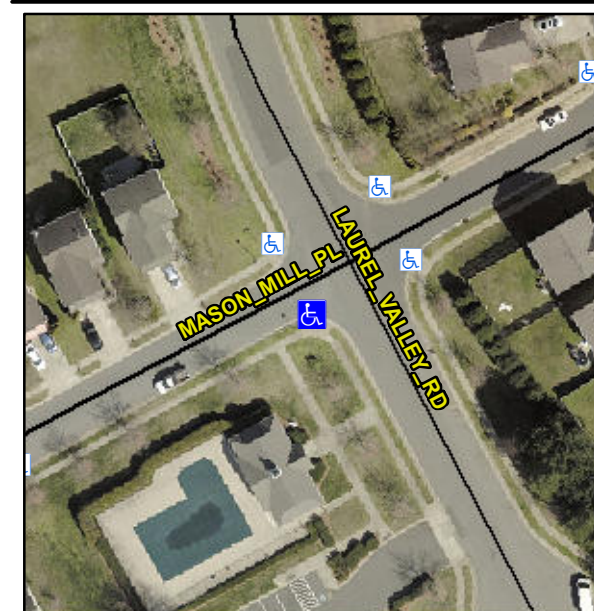
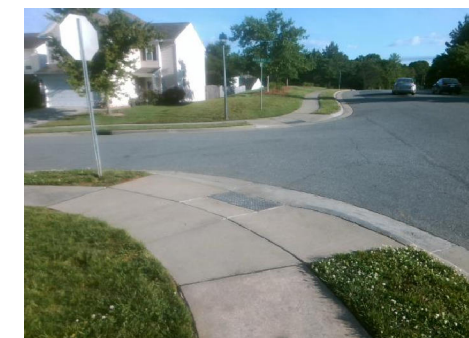
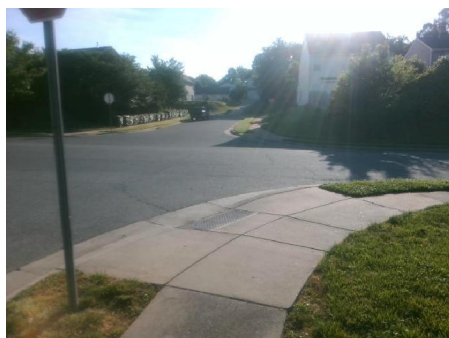
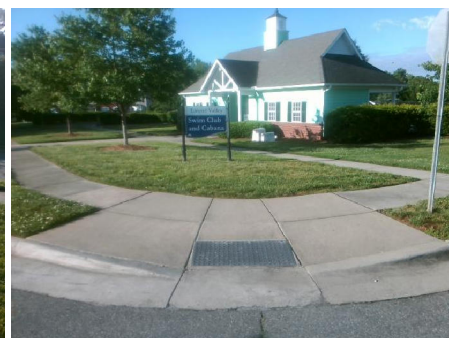
R304.5.1, R304.2.2, R304.5.3

Compliance	Description	Data	Compliance	Description	Data
N/A	Ramp Length (in)	48.0	No	Ramp Slope (%)	9.7
No	Ramp Width (in)	43.0	No	Ramp XSlope (%)	3.7
N/A	Flare Type LT	N/A	N/A	Flare Type RT	N/A
N/A	Flare Slope LT (%)	N/A	N/A	Flare Slope RT (%)	N/A
N/A	Flare Traversable LT?	N/A	N/A	Flare Traversable RT?	N/A
N/A	Landing Length (in)	N/A	N/A	DWS Provided?	N/A
N/A	Landing Width (in)	N/A	N/A	DWS Contrast?	N/A
N/A	Landing Slope (%)	N/A	N/A	DWS Length (in)	N/A
N/A	Landing X Slope (%)	N/A	N/A	DWS Full Width?	N/A
N/A	Landing Curb? (Y/N)	N/A	N/A	DWS Offset (in)	N/A
N/A	Shared Landing?	N/A			
N/A	Gutter Ponding?	N/A	N/A	Gutter Slope (%)	N/A
N/A	Gutter Lip Ht (in)	N/A	N/A	Gutter X Slope (%)	N/A
N/A	Painted X Walk1?	No	N/A	Painted X Walk2?	No
	X Walk 1 Direction	To E		X Walk 2 Direction	To N
N/A	X Walk 1 Width (in)	N/A	N/A	X Walk 2 Width (in)	N/A
	X Walk 1 Slope (%)	3.9		X Walk 2 Slope (%)	3.9
	X Walk 1 X Slope (%)	1.8		X Walk 2 X Slope (%)	4.2

N/A	Ramp inside XWalk1?	N/A	N/A	Ramp inside XWalk2?	N/A
	Road Slope (%)	2.0	N/A	Clear Space?	N/A
	Road X Slope (%)	5.9	N/A	Clear Space to XWalk (in)	N/A
N/A	Any Obstructions?	N/A	N/A	Storm Grate/Utility Hazard?	N/A
	Obstruction Type			Storm Grate/Utility Type	
		N/A			N/A
			Yes	Surface Condition? (G/P)	Good

Remove & Replace Curb Ramp With Two New Directional Ramps or Equivalent.
