Access Compliance Report

Public Rights-of-Way

(Curb Ramps)

| Intersection ID: 48425 | Main Street: KINNAIRDS_ST | Cross Street: EVANTON_LOCH_RD | Location: SW |

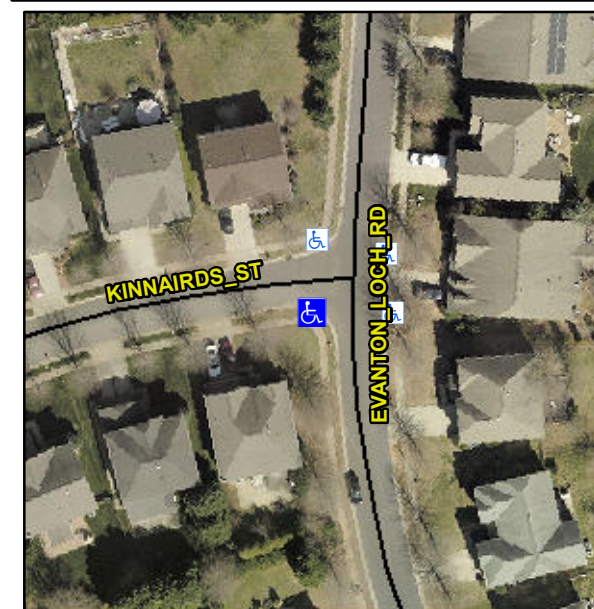
| ADA ID: A227405F10B2 | Ramp Type: PerpDiag | Initial Pass/Fail: Fail | Overall Compliance: No |
| Severity Score: 12.5 | | | |

| Compliance | Description | Data | Compliance | Description | Data |
|---|---|---|---|---|---|
| N/A | Ramp Length (in) | 48.0 | No | Ramp Slope (%) | 9.1 |
| Yes | Ramp Width (in) | 48.0 | Yes | Ramp XSlope (%) | 1.7 |

Possible Solutions:

Remove & Replace Curb Ramp With Two New Directional Ramps or Equivalent.

R304.2.2

Total Cost: \$ 3200.00
