Access Compliance Report

Public Rights-of-Way

(Curb Ramps)

| Intersection ID: 7033 | Main Street: DALECREST_DR | Cross Street: VALEVIEW_LN | Location: SW |

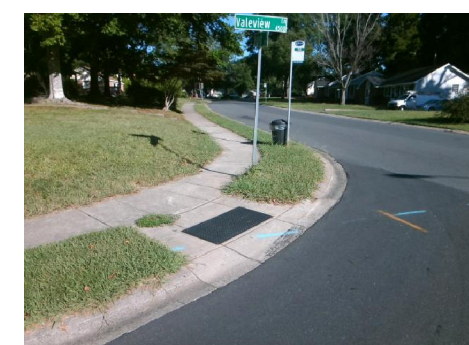
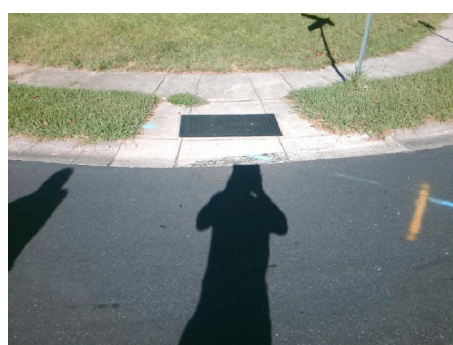
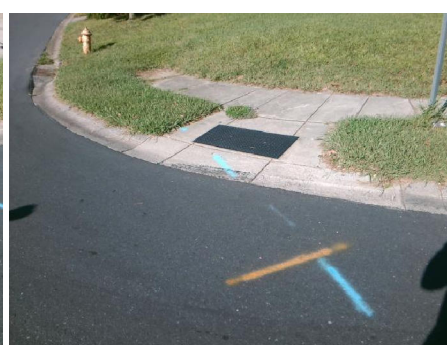
| ADA ID: A227E357052D | Ramp Type: Perp | Initial Pass/Fail: Fail | Overall Compliance: No |
| Severity Score: 22.5 | | | |

Not Found, R304.5.1, R304.2.2, R304.5.3

| Compliance | Description | Data | Compliance | Description | Data |
|---|---|---|---|---|---|
| N/A | Ramp Length (in) | 47.0 | No | Ramp Slope (%) | 8.6 |
| No | Ramp Width (in) | 40.0 | No | Ramp XSlope (%) | 3.5 |

Remove & Replace Entire Ramp.
