# Access Compliance Report

## Public Rights-of-Way

### (Curb Ramps)

| Intersection ID: 31813 | Main Street: WENDOVER_HILL_CT | Cross Street: CHURCHILL_RD | Location: SE |

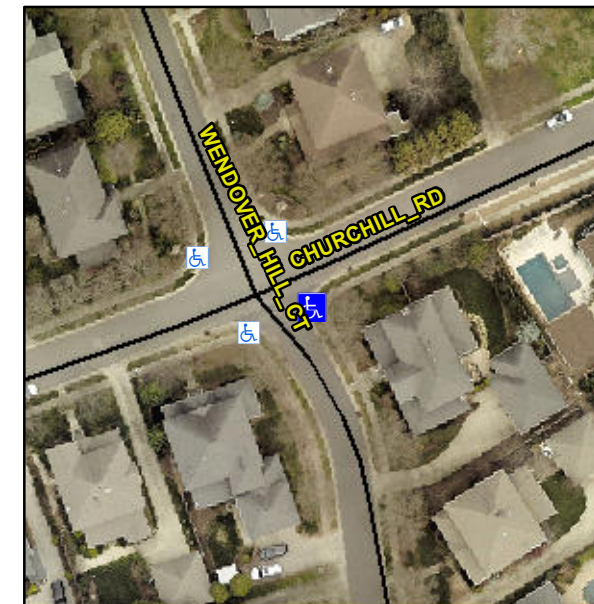
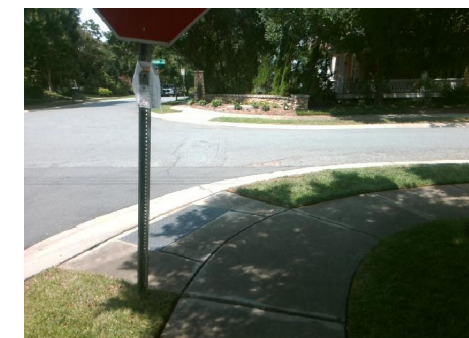
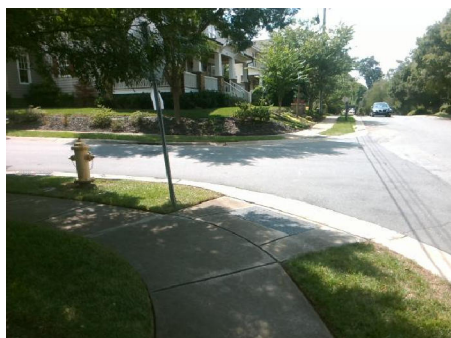
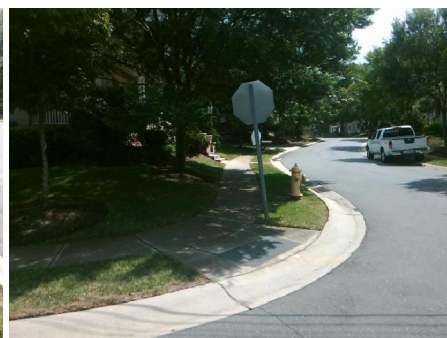
**R304.5.3, R305.2, R304.5.4**

| Compliance | Description | Data | Compliance | Description | Data |
|---|---|---|---|---|---|
| Yes | Ramp Width (in) | 48.0 | No | Ramp XSlope (%) | 2.8 |
| No | Landing X Slope (%) | 4.2 | Yes | DWS Full Width? | Yes |
| N/A | Landing Curb? (Y/N) | No | No | DWS Offset (in) | 5.0 |
| Yes | Gutter Ponding? | No | No | Gutter Slope (%) | 5.5 |
| Yes | Gutter Lip Ht (in) | 0.0 | No | Gutter X Slope (%) | 6.1 |

**Remove & Replace Curb Ramp With Two New Directional Ramps or Equivalent. Remove & Replace Gutter.**
