Access Compliance Report

Public Rights-of-Way

(Curb Ramps)

Intersection ID: 7186	Main Street: BEATTIES_FORD_RD	Cross Street: FAIRDALE_DR	Location: NW
ADA ID: A24BC2B9B9D3	Ramp Type: Perp	Initial Pass/Fail: Fail	Overall Compliance: No
Severity Score: 33.75			
Codes/Mitigation Info/Possible Solution		Field Measurements/Component Compliance

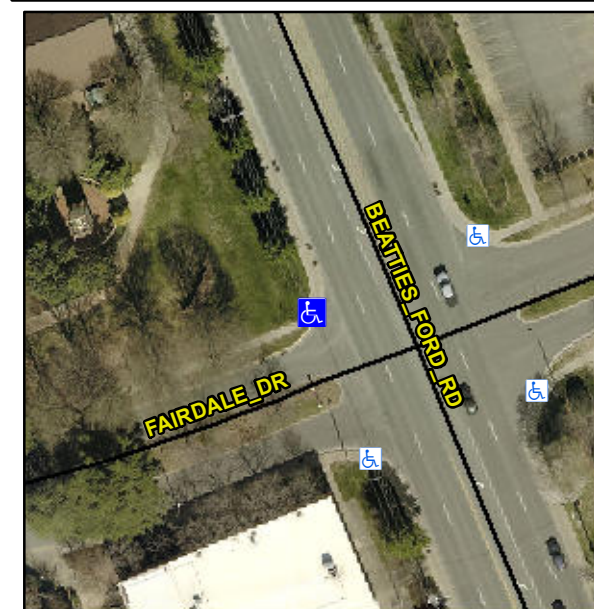
Compliance	Description	Data	Compliance	Description	Data
N/A	Ramp Length (in)	59.5	No	Ramp Slope (%)	12.5
No	Ramp Width (in)	46.0	Yes	Ramp XSlope (%)	0.5
N/A	Flare Type LT	N/A	N/A	Flare Type RT	N/A
N/A	Flare Slope LT (%)	N/A	N/A	Flare Slope RT (%)	N/A
N/A	Flare Traversable LT?	N/A	N/A	Flare Traversable RT?	N/A
N/A	Landing Length (in)	N/A	N/A	DWS Provided?	N/A
N/A	Landing Width (in)	N/A	N/A	DWS Contrast?	N/A
N/A	Landing Slope (%)	N/A	N/A	DWS Length (in)	N/A
N/A	Landing X Slope (%)	N/A	N/A	DWS Full Width?	N/A
N/A	Landing Curb? (Y/N)	N/A	N/A	DWS Offset (in)	N/A
N/A	Shared Landing?	N/A			
N/A	Gutter Ponding?	N/A	N/A	Gutter Slope (%)	N/A
N/A	Gutter Lip Ht (in)	N/A	N/A	Gutter X Slope (%)	N/A
N/A	Painted X Walk1?	No	N/A	Painted X Walk2?	N/A
	X Walk 1 Direction	To SE		X Walk 2 Direction	N/A
N/A	X Walk 1 Width (in)	N/A	N/A	X Walk 2 Width (in)	N/A
	X Walk 1 Slope (%)	1.3		X Walk 2 Slope (%)	N/A
	X Walk 1 X Slope (%)	6.5		X Walk 2 X Slope (%)	N/A

N/A	Ramp inside XWalk1?	N/A	N/A	Ramp inside XWalk2?	N/A
	Road Slope (%)	N/A	N/A	Clear Space?	N/A
	Road X Slope (%)	N/A	N/A	Clear Space to XWalk (in)	N/A
N/A	Any Obstructions?	N/A	N/A	Storm Grate/Utility Hazard?	N/A
	Obstruction Type			Storm Grate/Utility Type	
		N/A			N/A
			Yes	Surface Condition? (G/P)	Good

Possible Solutions:

Remove & Replace Entire Ramp.

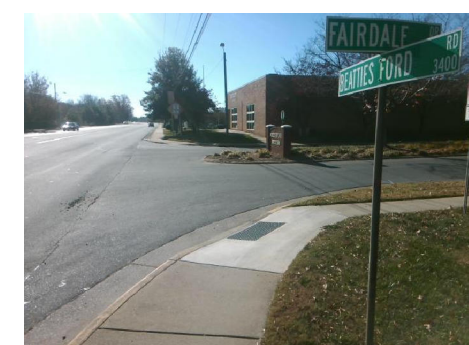
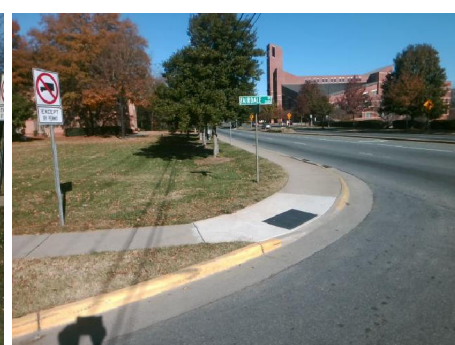
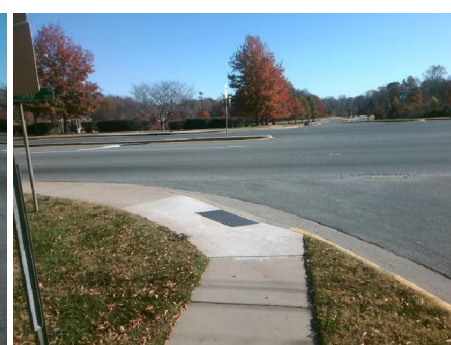
Not Found, R304.5.1, R304.2.2
