Access Compliance Report

Public Rights-of-Way

(Curb Ramps)

Intersection ID: 18767	Main Street: COOPER_DR	Cross Street: GLENHAM_DR	Location: NW
ADA ID: A258B555FE8	Ramp Type: Directional1	Initial Pass/Fail: Fail	Overall Compliance: No
Severity Score: 12.5			
Codes/Mitigation Info/Possible Solution		Field Measurements/Component Compliance

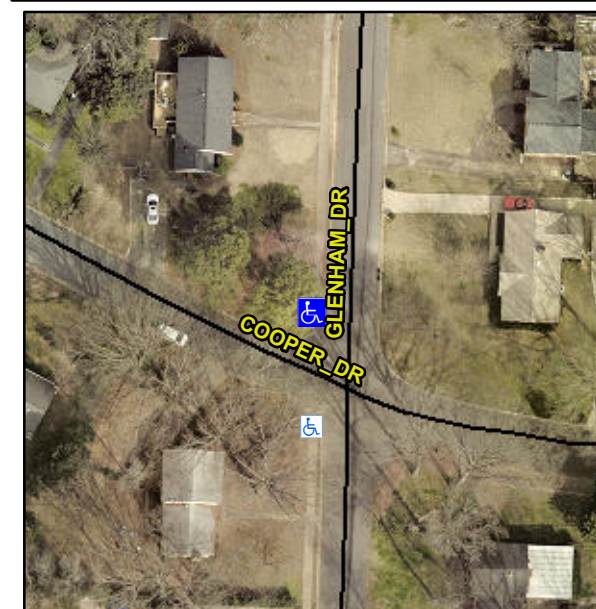
PROW/ADA:

R304.5.3

Compliance	Description	Data	Compliance	Description	Data
N/A	Ramp Length (in)	98.0	N/A	Grade Break?	N/A
Yes	Ramp Width (in)	60.0	N/A	Grade Break Slope (%)	0.0
Yes	Ramp Slope (%)	2.1	N/A	Grade Break XSlope (%)	0.0
No	Ramp XSlope (%)	5.3			
N/A	Flare Type LT	N/A	N/A	Flare Type RT	N/A
N/A	Flare Slope LT (%)	N/A	N/A	Flare Slope RT (%)	0.0
N/A	Flare Traversable LT?	N/A	N/A	Flare Traversable RT?	N/A
N/A	Landing Length (in)	0.0	N/A	DWS Provided?	N/A
N/A	Landing Width (in)	0.0	N/A	DWS Contrast?	N/A
N/A	Landing Slope (%)	0.0	N/A	DWS Length (in)	N/A
N/A	Landing X Slope (%)	0.0	N/A	DWS Full Width?	N/A
N/A	Landing Curb? (Y/N)	N/A	N/A	DWS Offset LT (in)	N/A
N/A	Shared Landing?	N/A	N/A	DWS Offset RT (in)	N/A
N/A	Gutter Ponding?	0.0	N/A	Gutter Slope (%)	N/A
N/A	Gutter Lip Ht (in)	0.0	N/A	Gutter X Slope (%)	N/A
N/A	Painted X Walk1?	No		Road Slope (%)	4.8
	X Walk 1 Direction	To SE		Road X Slope (%)	4.0
	X Walk 1 Width (in)	N/A		Clear Space?	N/A

X Walk 1 Slope (%)	4.8	N/A	Clear Space to XWalk (in)	N/A
	X Walk 1 X Slope (%)	4.0	N/A	Storm Grate/Utility Hazard?	N/A
N/A	Ramp inside XWalk1?	N/A		Storm Grate/Utility Type	
N/A	Any Obstructions?	N/A			N/A
	Obstruction Type		Yes	Surface Condition? (G/P)	Good
			N/A	Curb Slope (%)	25.0

Possible Solutions:

Remove & Replace Entire Ramp.

Total Cost: \$ 1600.00
