# Access Compliance Report

## Public Rights-of-Way

### (Curb Ramps)

Intersection ID: 48463	Main Street: PANGLEMONT_DR	Cross Street: CHANDLER_HAVEN_DR	Location:	N
ADA ID: A25E70AAFFCC2	Ramp Type: PerpDiag	Initial Pass/Fail: Fail	Overall Compliance: No	Severity Score: 8.75
Codes/Mitigation Info/Possible Solution		Field Measurements/Component Compliance

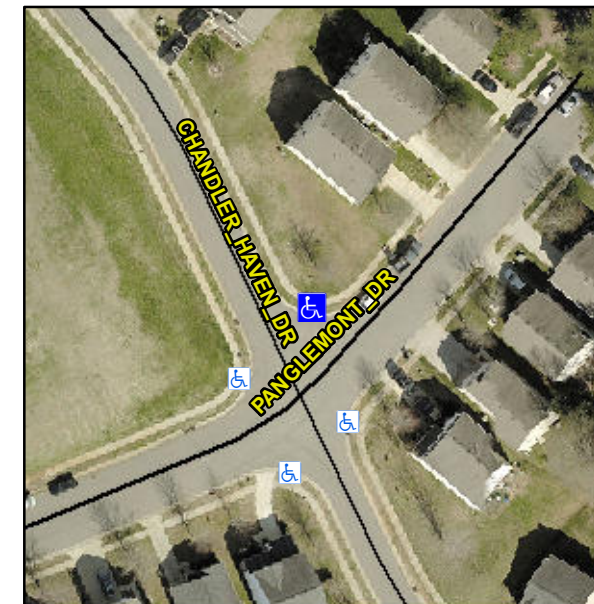
**Not Found, R304.5.1**

Compliance	Description	Data	Compliance	Description	Data
N/A	Ramp Length (in)	47.5	Yes	Ramp Slope (%)	7.2
No	Ramp Width (in)	46.5	Yes	Ramp XSlope (%)	2.0
N/A	Flare Type LT	N/A	N/A	Flare Type RT	N/A
N/A	Flare Slope LT (%)	N/A	N/A	Flare Slope RT (%)	N/A
N/A	Flare Traversable LT?	N/A	N/A	Flare Traversable RT?	N/A
N/A	Landing Length (in)	N/A	N/A	DWS Provided?	N/A
N/A	Landing Width (in)	N/A	N/A	DWS Contrast?	N/A
N/A	Landing Slope (%)	N/A	N/A	DWS Length (in)	N/A
N/A	Landing X Slope (%)	N/A	N/A	DWS Full Width?	N/A
N/A	Landing Curb? (Y/N)	N/A	N/A	DWS Offset (in)	N/A
N/A	Shared Landing?	N/A			
N/A	Gutter Ponding?	N/A	N/A	Gutter Slope (%)	N/A
N/A	Gutter Lip Ht (in)	N/A	N/A	Gutter X Slope (%)	N/A
N/A	Painted X Walk1?	No	N/A	Painted X Walk2?	No
	X Walk 1 Direction	To S		X Walk 2 Direction	To SW
N/A	X Walk 1 Width (in)	N/A	N/A	X Walk 2 Width (in)	N/A
	X Walk 1 Slope (%)	2.6		X Walk 2 Slope (%)	2.3
	X Walk 1 X Slope (%)	2.1		X Walk 2 X Slope (%)	1.0

N/A	Ramp inside XWalk1?	N/A	N/A	Ramp inside XWalk2?	N/A
	Road Slope (%)	0.2	N/A	Clear Space?	N/A
	Road X Slope (%)	2.9	N/A	Clear Space to XWalk (in)	N/A
N/A	Any Obstructions?	N/A	N/A	Storm Grate/Utility Hazard?	N/A
	Obstruction Type			Storm Grate/Utility Type	
		N/A			N/A
			Yes	Surface Condition? (G/P)	Good

**Remove & Replace Curb Ramp With Two New Directional Ramps or Equivalent.**
