# Access Compliance Report

## Public Rights-of-Way

### (Curb Ramps)

Intersection ID: 5092	Main Street: BROOKFIELD_POINTE_DR	Cross Street: PENNYCROSS_LN	Location: NE
ADA ID: A27CA7672F91	Ramp Type: Perp	Initial Pass/Fail: Fail	Overall Compliance: No
Severity Score: 1.25			
Codes/Mitigation Info/Possible Solution		Field Measurements/Component Compliance

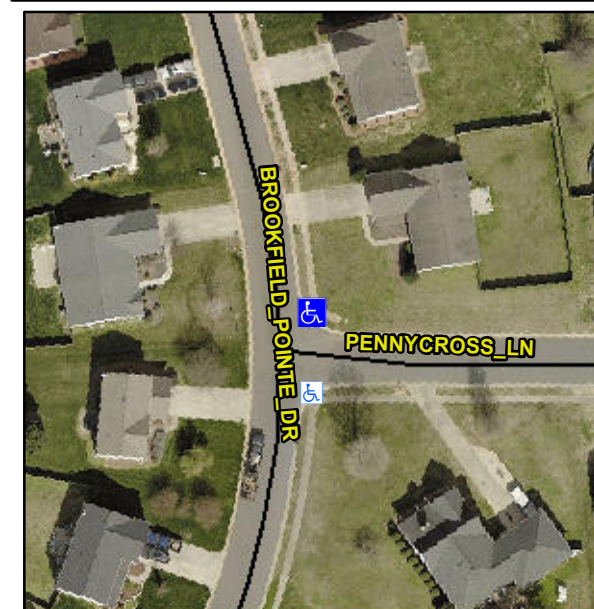
**Not Found, R304.5.3**

Compliance	Description	Data	Compliance	Description	Data
N/A	Ramp Length (in)	87.0	Yes	Ramp Slope (%)	5.8
Yes	Ramp Width (in)	48.0	No	Ramp XSlope (%)	3.2
N/A	Flare Type LT	N/A	N/A	Flare Type RT	N/A
N/A	Flare Slope LT (%)	N/A	N/A	Flare Slope RT (%)	N/A
N/A	Flare Traversable LT?	N/A	N/A	Flare Traversable RT?	N/A
N/A	Landing Length (in)	N/A	N/A	DWS Provided?	N/A
N/A	Landing Width (in)	N/A	N/A	DWS Contrast?	N/A
N/A	Landing Slope (%)	N/A	N/A	DWS Length (in)	N/A
N/A	Landing X Slope (%)	N/A	N/A	DWS Full Width?	N/A
N/A	Landing Curb? (Y/N)	N/A	N/A	DWS Offset (in)	N/A
N/A	Shared Landing?	N/A			
N/A	Gutter Ponding?	N/A	N/A	Gutter Slope (%)	N/A
N/A	Gutter Lip Ht (in)	N/A	N/A	Gutter X Slope (%)	N/A
N/A	Painted X Walk1?	No	N/A	Painted X Walk2?	N/A
	X Walk 1 Direction	To S		X Walk 2 Direction	N/A
N/A	X Walk 1 Width (in)	N/A	N/A	X Walk 2 Width (in)	N/A
	X Walk 1 Slope (%)	1.2		X Walk 2 Slope (%)	N/A
	X Walk 1 X Slope (%)	1.3		X Walk 2 X Slope (%)	N/A

N/A	Ramp inside XWalk1?	N/A	N/A	Ramp inside XWalk2?	N/A
	Road Slope (%)	N/A	N/A	Clear Space?	N/A
	Road X Slope (%)	N/A	N/A	Clear Space to XWalk (in)	N/A
N/A	Any Obstructions?	N/A	N/A	Storm Grate/Utility Hazard?	N/A
	Obstruction Type			Storm Grate/Utility Type	
		N/A			N/A
		Yes		Surface Condition? (G/P)	Good

**Remove & Replace Entire Ramp.**

Total Cost: \$ 1850.00
