Access Compliance Report Public Rights-of-Way (Curb Ramps)

•	-	-					
Intersection ID: 48429	Main Street: ROUSAY_RD		Cross Street: SEAMILL_RD					Location:	NW
ADA ID: A281DFA21E7E	Ramp Ty	Initial Pa	Initial Pass/Fail: Fail Overall Compliance: No				o Severity Score:	25	
Codes/Mitigation Info/Possible Solution				Field Measurements/Component Compliance					
		Possible Solutions:		Compliance Description			Data Compliance Description		
4		Remove & Replace Curb Ramp V	Vith I	N/A	Ramp Length (in)	45.0	No	Ramp Slope (%)	9.6
		Two New Directional Ramps or		Yes	Ramp Width (in)		No	Ramp XSlope (%)	5.5
		Equivalent.		N/A	Flare Type LT	N/A	N/A	Flare Type RT	N/A
				N/A	Flare Slope LT (%)		N/A	Flare Slope RT (%)	N/A
				N/A	Flare Traversable LT?	N/A		Flare Traversable RT?	N/A
		2		N/A	Landing Length (in)	N/A		DWS Provided?	N/A
		Surveyor Notes:		N/A	Landing Width (in)	N/A	N/A	DWS Contrast?	N/A
ROUBAY RD		,		N/A	Landing Slope (%)	N/A		DWS Length (in)	N/A
		N/A			o ,			3 ()

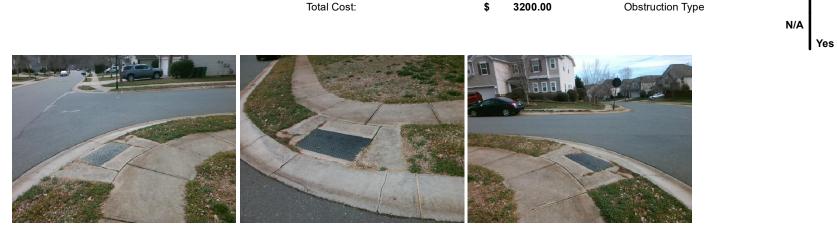
N/A	Landing X Slope (%)	N/A	N/A	DWS Full Width?	N/A
the second secon				N/A	Landing Curb? (Y/N)	N/A	N/A	DWS Offset (in)	N/A
				N/A	Shared Landing?	N/A			
Same + Karl TE		PROW/ADA:		N/A	Gutter Ponding?	N/A	N/A	Gutter Slope (%)	N/A
	11	Not Found, R304.2.2, R304.5.3	1	N/A	Gutter Lip Ht (in)	N/A	N/A	Gutter X Slope (%)	N/A
		I	N/A	Painted X Walk1?	No	N/A	Painted X Walk2?	No	
The second the				X Walk 1 Direction	To SW		X Walk 2 Direction	To SE	
	The second second second		I	N/A	X Walk 1 Width (in)	N/A	N/A	X Walk 2 Width (in)	N/A
Street 1 Name	ROUSAY RD				X Walk 1 Slope (%)	3.7		X Walk 2 Slope (%)	0.9
Stop Condition-Street 2	StopSign				X Walk 1 X Slope (%)	4.6		X Walk 2 X Slope (%)	3.3
Street 2 Name	SEAMILL RD			N/A	Ramp inside XWalk1?	N/A	N/A	Ramp inside XWalk2?	N/A
Stop Condition-Street 1	None				Road Slope (%)	3.1	N/A	Clear Space?	N/A
					Road X Slope (%)	0.2	N/A	Clear Space to XWalk (in)	N/A
				N/A	Any Obstructions?	N/A	N/A	Storm Grate/Utility Hazard?	N/A

Total Cost: \$ 3	200.00		Obstruction Type			Storm Grate/Utility Type	
		····· • •				N/A			N/A
						13/A	1		11/2
