# Access Compliance Report

## Public Rights-of-Way

### (Curb Ramps)

Intersection ID: 8333	Main Street: BROOKSHIRE_BV	Cross Street: S_I-85_EXIT_36_RA	Location: NE
ADA ID: A28BB4431C13	Ramp Type: Perp	Initial Pass/Fail: Fail	Overall Compliance: No
			Severity Score: 21.25

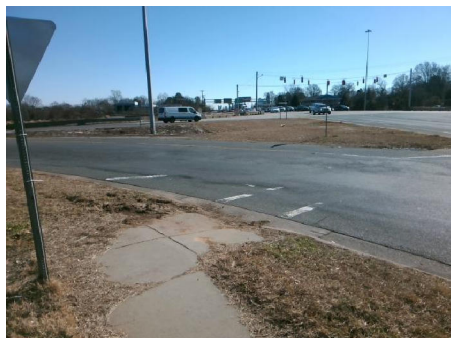
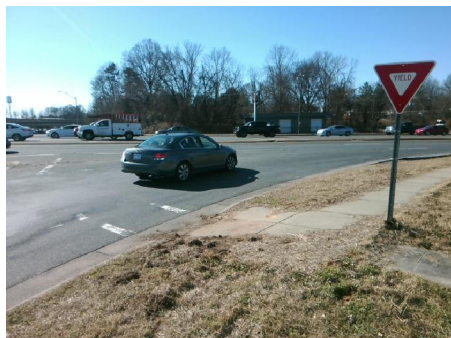
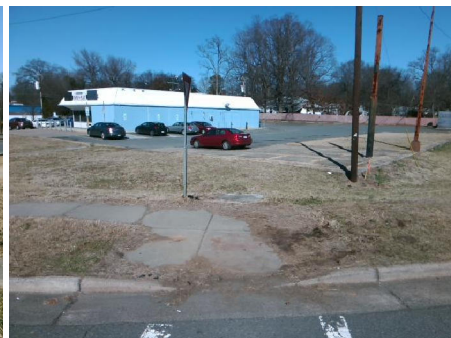
Possible Solutions:		Compliance	Description	Data	Compliance	Description	Data
	Remove & Replace Entire Ramp.		N/A	Ramp Length (in)	54.0	No	Ramp Slope (%)	10.3
			No	Ramp Width (in)	42.0	Yes	Ramp XSlope (%)	0.1
			N/A	Flare Type LT	N/A	N/A	Flare Type RT	N/A
			N/A	Flare Slope LT (%)	N/A	N/A	Flare Slope RT (%)	N/A
			N/A	Flare Traversable LT?	N/A	N/A	Flare Traversable RT?	N/A
			N/A	Landing Length (in)	N/A	N/A	DWS Provided?	N/A
			N/A	Landing Width (in)	N/A	N/A	DWS Contrast?	N/A
			N/A	Landing Slope (%)	N/A	N/A	DWS Length (in)	N/A
			N/A	Landing X Slope (%)	N/A	N/A	DWS Full Width?	N/A
Surveyor Notes:	N/A		N/A	Landing Curb? (Y/N)	N/A	N/A	DWS Offset (in)	N/A
			N/A	Shared Landing?	N/A			
	PROW/ADA:		N/A	Gutter Ponding?	N/A	N/A	Gutter Slope (%)	N/A
	Not Found, R304.5.1, R304.2.2		N/A	Gutter Lip Ht (in)	N/A	N/A	Gutter X Slope (%)	N/A

N/A	Painted X Walk1?	Yes	N/A	Painted X Walk2?	N/A
				X Walk 1 Direction	To SW		X Walk 2 Direction	N/A
			N/A	X Walk 1 Width (in)	55.0	N/A	X Walk 2 Width (in)	N/A
				X Walk 1 Slope (%)	6.4		X Walk 2 Slope (%)	N/A
				X Walk 1 X Slope (%)	0.6		X Walk 2 X Slope (%)	N/A
			N/A	Ramp inside XWalk1?	Yes	N/A	Ramp inside XWalk2?	N/A
			Road Slope (%)	N/A	N/A	Clear Space?	N/A	
			Road X Slope (%)	N/A	N/A	Clear Space to XWalk (in)	N/A	
		N/A	Any Obstructions?	N/A	N/A	Storm Grate/Utility Hazard?	N/A	
			Obstruction Type			Storm Grate/Utility Type		
					N/A		N/A	
					Yes	Surface Condition? (G/P)	Good	
Total Cost:		\$ 1850.00
