Access Compliance Report

Public Rights-of-Way

(Curb Ramps)

Intersection ID: 9140	Main Street: FREEDOM_DR	Cross Street: THRIFTWOOD_DR	Location:	E
ADA ID: A28BE1BFB5CA	Ramp Type: Perp	Initial Pass/Fail: Fail	Overall Compliance: No	Severity Score: 8.75

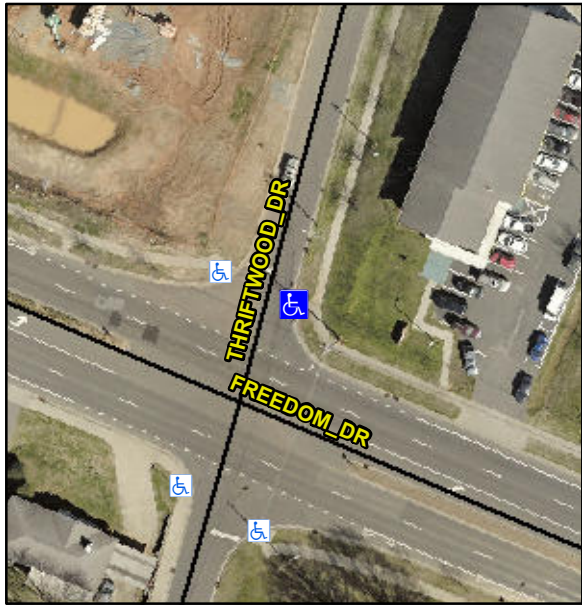
PROW/ADA:		Not Found, R304.5.1	N/A	Shared Landing?	N/A			
			N/A	Gutter Ponding?	N/A	N/A	Gutter Slope (%)	N/A
			N/A	Gutter Lip Ht (in)	N/A	N/A	Gutter X Slope (%)	N/A
			N/A	Painted X Walk1?	No	N/A	Painted X Walk2?	N/A
				X Walk 1 Direction	To NW		X Walk 2 Direction	N/A
			N/A	X Walk 1 Width (in)	N/A	N/A	X Walk 2 Width (in)	N/A
				X Walk 1 Slope (%)	1.1		X Walk 2 Slope (%)	N/A
				X Walk 1 X Slope (%)	1.1		X Walk 2 X Slope (%)	N/A
			N/A	Ramp inside XWalk1?	N/A	N/A	Ramp inside XWalk2?	N/A
				Road Slope (%)	N/A	N/A	Clear Space?	N/A
				Road X Slope (%)	N/A	N/A	Clear Space to XWalk (in)	N/A
			N/A	Any Obstructions?	N/A	N/A	Storm Grate/Utility Hazard?	N/A
				Obstruction Type			Storm Grate/Utility Type	
					N/A			N/A
						Yes	Surface Condition? (G/P)	Good
Total Cost:		\$ 1850.00

<div>Street 1 Name<div>THRIFTWOOD DR</div></div> <div>Stop Condition-Street 2<div>StopSign</div></div> <div>Street 2 Name<div>N/A</div></div> <div>Stop Condition-Street 1<div>N/A</div></div>	Possible Solutions:		Compliance	Description	Data	Compliance	Description	Data
	Remove & Replace Entire Ramp.		N/A	Ramp Length (in)	82.0	Yes	Ramp Slope (%)	6.7
			No	Ramp Width (in)	47.0	Yes	Ramp XSlope (%)	0.4
			N/A	Flare Type LT	N/A	N/A	Flare Type RT	N/A
			N/A	Flare Slope LT (%)	N/A	N/A	Flare Slope RT (%)	N/A
			N/A	Flare Traversable LT?	N/A	N/A	Flare Traversable RT?	N/A
			N/A	Landing Length (in)	N/A	N/A	DWS Provided?	N/A
			N/A	Landing Width (in)	N/A	N/A	DWS Contrast?	N/A
			N/A	Landing Slope (%)	N/A	N/A	DWS Length (in)	N/A
			N/A	Landing X Slope (%)	N/A	N/A	DWS Full Width?	N/A
Surveyor Notes:		N/A	N/A	Landing Curb? (Y/N)	N/A	N/A	DWS Offset (in)	N/A
