# Access Compliance Report

## Public Rights-of-Way

### (Curb Ramps)

Intersection ID: 20184	Main Street: SOUTH_PARK_DR	Cross Street: SHARON_RD	Location: W
ADA ID: A28DACD3B414	Ramp Type: Perp	Initial Pass/Fail: Fail	Overall Compliance: No
		Severity Score: 12.5

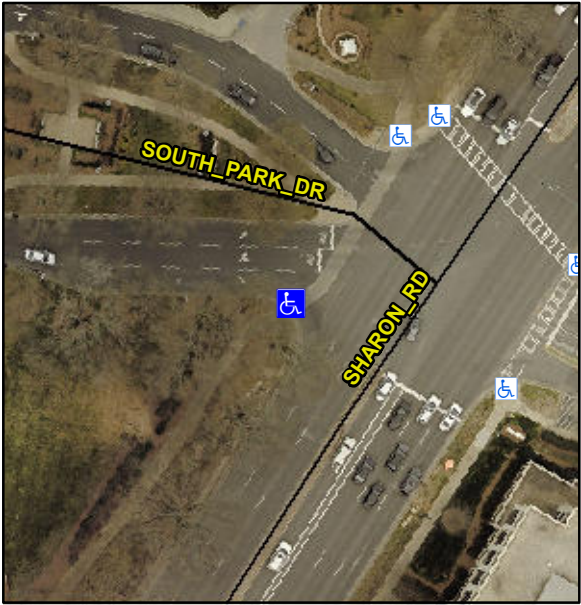
Possible Solutions:		<b>Compliance</b>	<b>Description</b>	<b>Data</b>
	<b>Remove &amp; Replace Entire Ramp.</b>		<b>Yes</b>	Ramp Length (in)	121.0
			<b>No</b>	Ramp Width (in)	76.0
			<b>N/A</b>	Flare Type LT	N/A
			<b>N/A</b>	Flare Slope LT (%)	N/A
			<b>N/A</b>	Flare Traversable LT?	N/A
			<b>N/A</b>	Landing Length (in)	N/A
			<b>N/A</b>	Landing Width (in)	N/A
			<b>N/A</b>	Landing Slope (%)	N/A
			<b>N/A</b>	Landing X Slope (%)	N/A
<p>Surveyor Notes:</p> <p><b>N/A</b></p> <p>PROW/ADA:</p> <p><b>R304.5.3</b></p>			<b>N/A</b>	Flare Type RT	N/A
			<b>N/A</b>	Flare Slope RT (%)	N/A
			<b>N/A</b>	Flare Traversable RT?	N/A
			<b>N/A</b>	DWS Provided?	N/A
			<b>N/A</b>	DWS Contrast?	N/A
			<b>N/A</b>	DWS Length (in)	N/A
			<b>N/A</b>	DWS Full Width?	N/A
			<b>N/A</b>	DWS Offset (in)	N/A
			<b>N/A</b>	Shared Landing?	N/A
			<b>N/A</b>	Gutter Ponding?	N/A

<b>N/A</b>	Gutter Lip Ht (in)	N/A
			<b>N/A</b>	Painted X Walk1?	Yes
				X Walk 1 Direction	To NE
			<b>N/A</b>	X Walk 1 Width (in)	70.0
				X Walk 1 Slope (%)	4.8
				X Walk 1 X Slope (%)	4.2
			<b>N/A</b>	Ramp inside XWalk1?	Yes
			<b>N/A</b>	Road Slope (%)	N/A
			<b>N/A</b>	Road X Slope (%)	N/A
			<b>N/A</b>	Any Obstructions?	N/A
Total Cost:		\$ 1850.00		Obstruction Type	
			<b>N/A</b>		N/A
			<b>Yes</b>	Surface Condition? (G/P)	Good
