## Access Compliance Report Public Rights-of-Way (Curb Ramps)

Intersection ID: 46343 Ma		Street: MEADOW_KNOLL_DR		Cross Street: STREAM_BANK_DR				Location:	NE
ADA ID: A2959EA2F448 Ramp 1		Type: PerpDiag Initial			Il Pass/Fail: Fail Overall Compliance: N			o Severity Score:	46.25
Codes/Mitigation Info/Possible Solution				Field Measurements/Component Compliance					
	EZ	Possible Solutions:		Compliance Description			Data Compliance Description

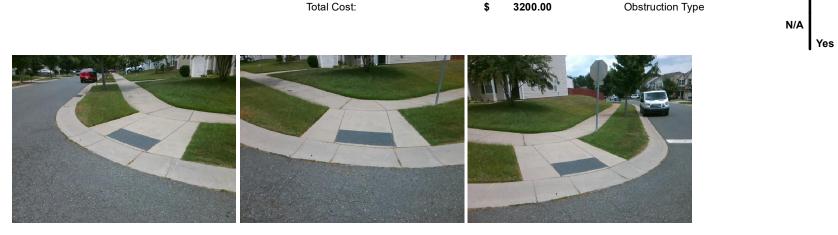
- Martine Party - Contraction		Remove & Replace Curb Ramp W Two New Directional Ramps or Equivalent.	With	N/A	Ramp Length (in)	83.0	No	Ramp Slope (%)	9.4
the property of the light				No	Ramp Width (in)	42.0	No	Ramp XSlope (%)	9.5
The state of the second				N/A	Flare Type LT	N/A	N/A	Flare Type RT	N/A
				N/A	Flare Slope LT (%)	N/A	N/A	Flare Slope RT (%)	N/A
				N/A	Flare Traversable LT?	N/A	N/A	Flare Traversable RT?	N/A
				N/A	Landing Length (in)	N/A	N/A	DWS Provided?	N/A
	THE AM BANK DR	Surveyor Notes:		N/A	Landing Width (in)	N/A	N/A	DWS Contrast?	N/A
		N/A		N/A	Landing Slope (%)	N/A	N/A	DWS Length (in)	N/A
	Subarna	1071		N/A	Landing X Slope (%)	N/A	N/A	DWS Full Width?	N/A
in the second se	N		N/A	Landing Curb? (Y/N)	N/A	N/A	DWS Offset (in)	N/A	
				N/A	Shared Landing?	N/A		ζ, γ	
A Company of the Property of t	RAAP.	PROW/ADA:		N/A	Gutter Ponding?	N/A	N/A	Gutter Slope (%)	N/A
A THE REAL PROPERTY OF	Not Found, R304.5.1, R304.2.2	_	N/A	Gutter Lip Ht (in)	N/A	N/A	Gutter X Slope (%)	N/A

R304.5.3	,	N/A	Painted X Walk1?	No	N/A	Painted X Walk2?	No	
1 - 1 - 3					X Walk 1 Direction	To W		X Walk 2 Direction	To S
				N/A	X Walk 1 Width (in)	N/A	N/A	X Walk 2 Width (in)	N/A
Street 1 Name	MEADOW KNOLL DR	-			X Walk 1 Slope (%)	5.9		X Walk 2 Slope (%)	3.8
Stop Condition-Street 2	None				X Walk 1 X Slope (%)	5.0		X Walk 2 X Slope (%)	5.7
Street 2 Name	STREAM BANK DR			N/A	Ramp inside XWalk1?	N/A	N/A	Ramp inside XWalk2?	N/A
Stop Condition-Street 1	StopSign				Road Slope (%)	7.0	N/A	Clear Space?	N/A
					Road X Slope (%)	1.8	N/A	Clear Space to XWalk (in)	N/A
				N/A	Any Obstructions?	N/A	N/A	Storm Grate/Utility Hazard?	N/A
		Total Cost: \$	3200.00		Obstruction Type			Storm Grate/Utility Type	
						N/A			N/A
